Failure Analysis Capabilities for PV Systems

FLORIN ANCUTA, COSTIN CEPISCA
Department of Measurements and Static Convertors
University POLITEHNICA of Bucharest
Splaiul Independentei 313, 060042 Bucharest
ROMANIA
florin.ancuta@gmail.com, costin.cepisca@upb.ro

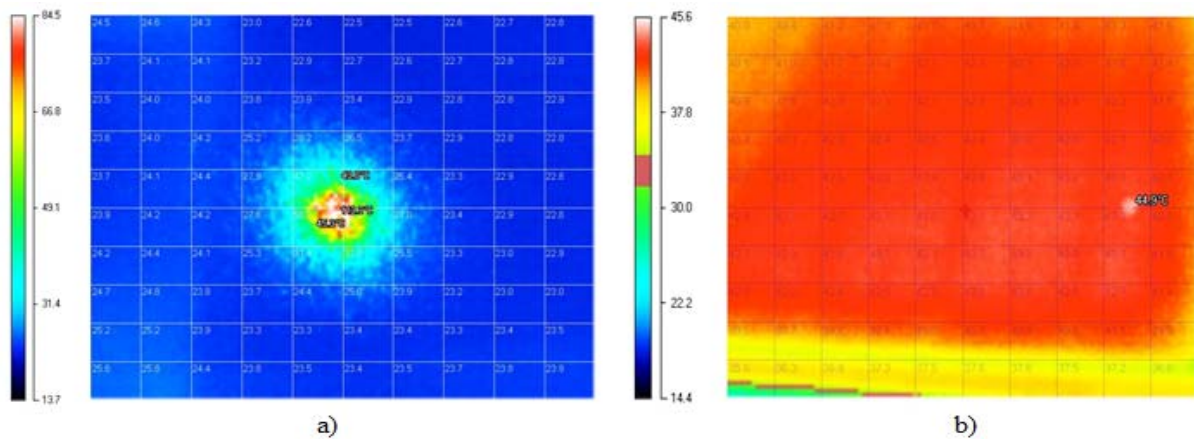
Fig. 2. Visible hot spots resulted as dirt and impurities got stuck to the panels

In figure 2 there are hot spots detected, without externally visible damage on the panel surface. Thus, the problem must be attributed to internal causes, corrosion being one possible candidate. Invisible hot spots corresponding to areas where the internal structure of the panels is beginning to decay is visible with an IR camera help.

A thing that is good to be remarked is that some spots are by their nature invisible to the naked eye, contrary to the dust and impurities deposits, but with the infrared equipment even those ones are easily seen removed as quickly as possible- fig. 2.

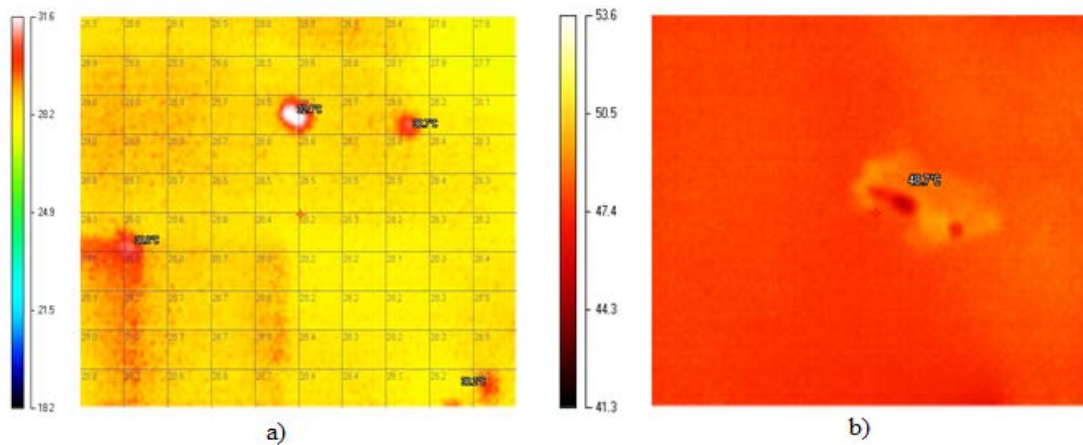
Fig. 3. Internal structural defect of a PV cell.

In figure 3 hot spots are detected, without externally visible damage on the panel surface. Thus, the problem must be attributed to internal causes, corrosion being one possible candidate. Invisible hot spots corresponding to areas where the internal structure of the panels is beginning to decay is visible with an IR camera help.
