Timber Defects In Building: A Study of Telapak Naning, Malacca, Malaysia

Key-Words: Building Survey, Prioritise Ranking System, Timber Defects

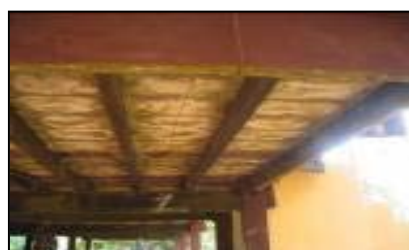
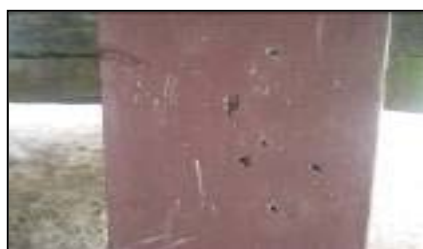
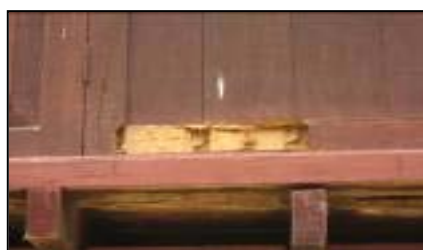
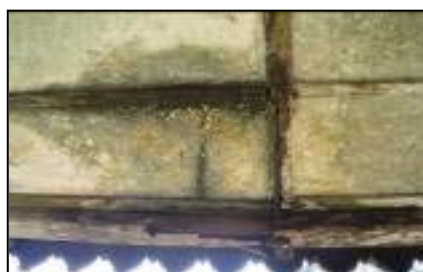
Figure 5 (a), (b), (c) and (d): Defects which occurred at the surface of the timber at the site.

By the time survey is conducted, the ventilation meter indicates the surrounding temperature is 27 degree Celsius, with the air velocity of 2.5 m/s. This shows the possibility of low moisture content and providing the dry surface for the whole site. Proceed with the analysis, the result of condition survey is shown in Table 4. According to the number of appearances, rotting is the highest number of occurrence, followed by termites attack and beetles. Therefore, insect attacks and fungal infestation remain as the main causes of timber defects, since more than half of the number of defects recorded fall within these two categories of causes. The location of defects is mostly found in the exterior part of the house. The defects can be seen in Fig. 5.

For the analysis of timber defect prioritise ranking, the lowest total marks is 5, whereas the highest score recorded is 16. The indication for marking system is the priority should be given to the lowest score. In this condition survey, the element of roof beam at staircase area is found to have the serious defects cause by fungal infestation, with the type of defect is dry rot. The score for this defected roof beam is 5 with the occurrence number is 1. The second serious defect with total mark of 10 is still cause by the fungal infestation, and located behind the area of defected roof beam. Total mark of 16 is recorded as the highest with prioritise ranking number 6; and 4 number of defects occurrence. The defects which classified as the least priority defects are caused mostly by the insect attacks.

From this finding, suffice to mention that all timber defects found in Telapak Naning is classified as not very much severe, since no severity index above 50% is recorded. Termites attack found to be the lowest index (below 10%) and considered not severe to the house. The finding of severity index is then confirmed and supported the score of condition assessment, which good with no severe defects found. From the research conducted, the main finding can be drawn as below:-

Building condition survey reveals that the house is still in a good condition and classified as good. For maintenance purpose, the custodian should give priority for replacement of the roof beam element at the staircase area (the lean-to-roof structure). In term of severity level, frankly to quote that no element had seriously damaged. This is because all the timber defects are recorded to be below of 50% severity index. Keep in mind that only one portion of the house namely roof beam at the staircase area that need to be replace urgently, otherwise the severity level reflects the number of defects occurrence for the whole structure. The limitation of the research
