Analysis of the Potential for Nearly Circular Slope Failure Using On-site Survey Information with Adverse Calculation

T. KERH, Y.M. WANG and H.C. TSAI

Department of Civil Engineering
National Pingtung University of Science and Technology
Pingtung 91207, TAIWAN
E-mail: tfkerh@mail.npust.edu.tw

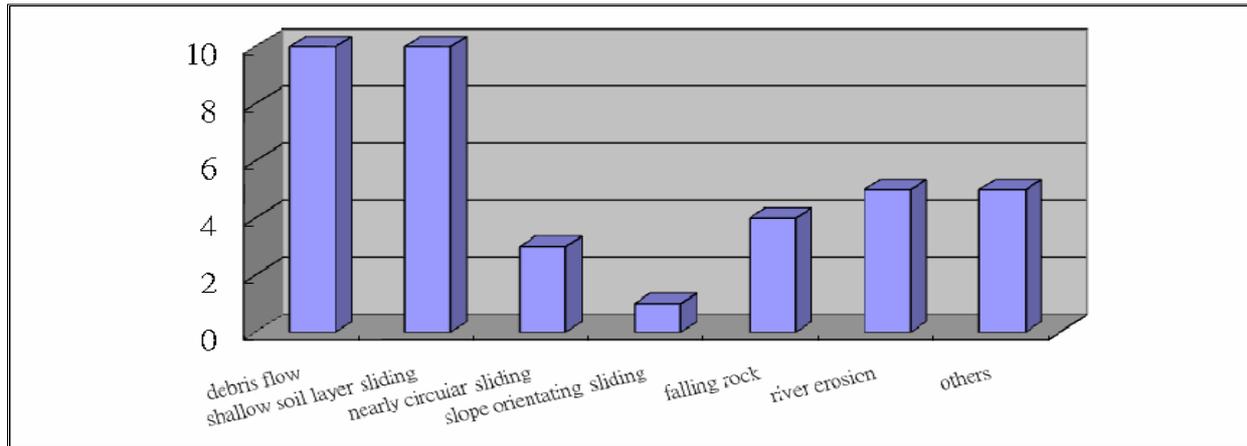
Figure 2. Distribution of slope damage types.

An on-site survey is essential to understand the characteristics of the slope at the specified road section, which may include location, direction, gradient, width, height, stratum category, planting, failure style, water seepage, original protection, and other items. A total of 38 slopes within the present studied area were investigated and several on-site information were recorded, where type of slope failure is of primary concern in this paper. From survey information, six basic types of slope damage were identified, including debris flow, shallow soil layer sliding, nearly circular sliding, slope oriented sliding, falling rock, river erosion, and others. As seen in Figure 2 is the distribution of slope for each damage type, the amounts and percentages are 10 (26%), 10 (26%), 3 (8%), 1 (3%), 4 (11%), 5 (13%), and 5 (13%) for debris flow, shallow soil layer sliding, nearly circular sliding, slope oriented sliding, falling rock, river erosion, and others, respectively.

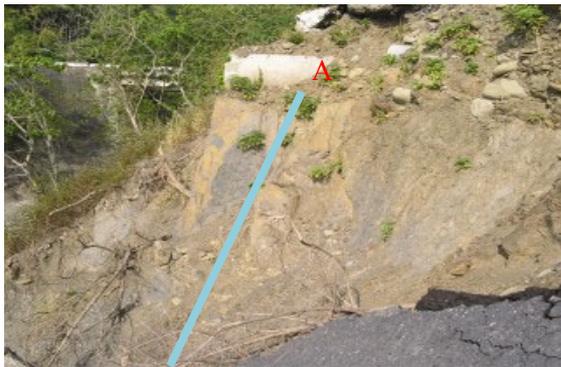
Picture 1. Actual profile of slope failure at 01k+200.

For the type of nearly circular slope failure, Picture 1 shows the actual profile (A-A) of slope failure at location 01k+200. Because no direct experimental data is available in this region, it is hard to evaluate its sliding surface from computing result. But from the survey result of the

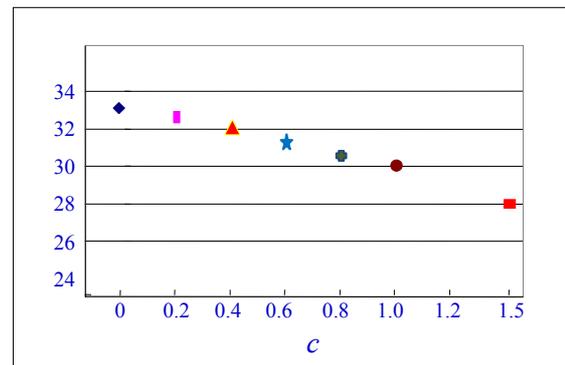
Figure 3. Relationship of $c - \phi$ values at 01k+200.

mountain area for the whole island of Taiwan by Bureau of Soil Conservation, Council of Agriculture from the year 1986 to 1998, it can be seen that the ϕ value of cohesive soil range is between 17.7° to 37.7° . By using this estimation, and obtaining the soil unit weight $r = 2.02$ from on-site sample, the relationship between cohesion force and friction angle ($c - \phi$) with factor of safety $FS = 1.0$ shown in Figure 3 can be calculated. The plot exhibits that the slope failure occurs in a shallow soil depth, and if ϕ value range is between 28.0° to 34.0° , then c value range is possibly between $0t/m^2$ to $1.5t/m^2$.

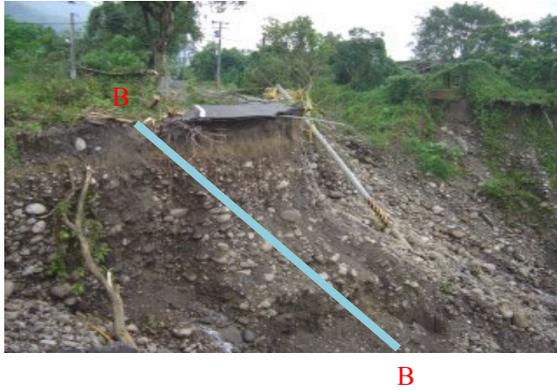
Picture 2. Actual profile of slope failure at 13k+730.

Now for the cases at locations 13k+730 and 18k+650, as there are on-site geological boring data for the road section in the present study [19-20], it is possible to perform adverse calculations by using available computer program. For the first case, Picture 2 shows its actual profile of slope failure (B-B). The tendency of slope failure can be estimated by inputting unit weight $r = 1.6$ and cohesion force $c = 0$, to obtain friction angle $\phi = 31.5^\circ$ for the entire slope when factor of safety equals 1.0. A reasonable agreement of actual profile and solution from GSTABLE7 calculation is shown in Figure 4. Additionally, the friction angle matches with boring test result $\phi = 30^\circ - 35^\circ$, which can prove the reliability of using adverse calculation for this case. The computing result is displayed in Figure 5, it is seen that the indicated line surface with lowest safety factor ($FS_{min} = 0.782$) has the highest possibility of sliding the next time if no protection work is constructed on this slope.

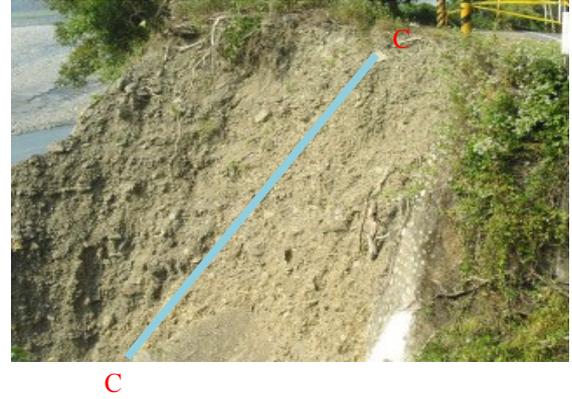
Picture 3. Actual profile of slope failure at 18k+650.

Similarly, the actual slope failure profile (C-C) for the second case is displayed in Picture 3, and a comparison of actual profile with GTABLE7 solution is shown in Figure 6. It can be seen that the trend of the calculated surface of slope failure is in reasonable agreement with the actual result in

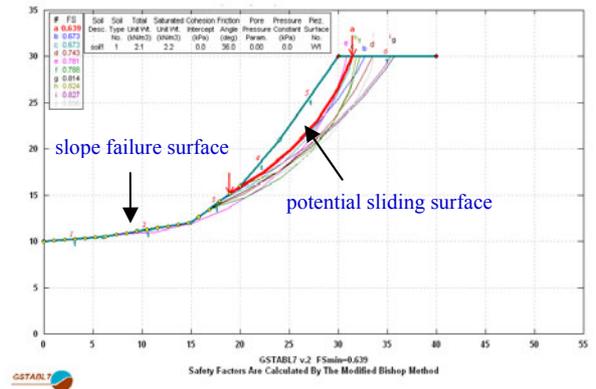
Figure 7. Potential sliding surface at 18k+650.

the picture. For the computing results with parameters $r = 2.07$ and $c = 0$ to obtain $\phi = 36^\circ$, the critical surface for minimum safety factor $FS_{min} = 0.639$ can then be predicted and shown in Figure 7. In general situation, the critical sliding surface will occur in a shallow layer if the property of soil has a high friction angle with a low cohesion force. On the other hand, if the property of soil has a low friction angle with a high cohesion force, then the critical surface will occur in a deep layer. Therefore, two cases of slope failure mentioned above are currently in unstable conditions. They will have the second nearly circular failure in a shallow layer, if no further action is taken to repair the slopes before the next heavy rain.

For the case of nearly circular slope failure, various types of retaining wall and planting technique depend on actual geological conditions may be applied to increase its slope stability.
