# **CAE** Techniques Investigation of Rocket Parts Malfunction

*Abstract:* In this paper, an investigation of possible causes which could lead to firig incidents is presented. The subject submitted to this analysis is an romanian portable antiaircraft rocket, self-guided in IR radiation. Once the causes identified, some design corrections are required. In order to carry out this work, highly use of FEM software is needed. Thus, the problems formulation using COSMOS, LS-DYNA and FLUENT were very useful. Also, a series of experimental tests were developed in laboratory and in real firing situation in order to validate the simulation results.

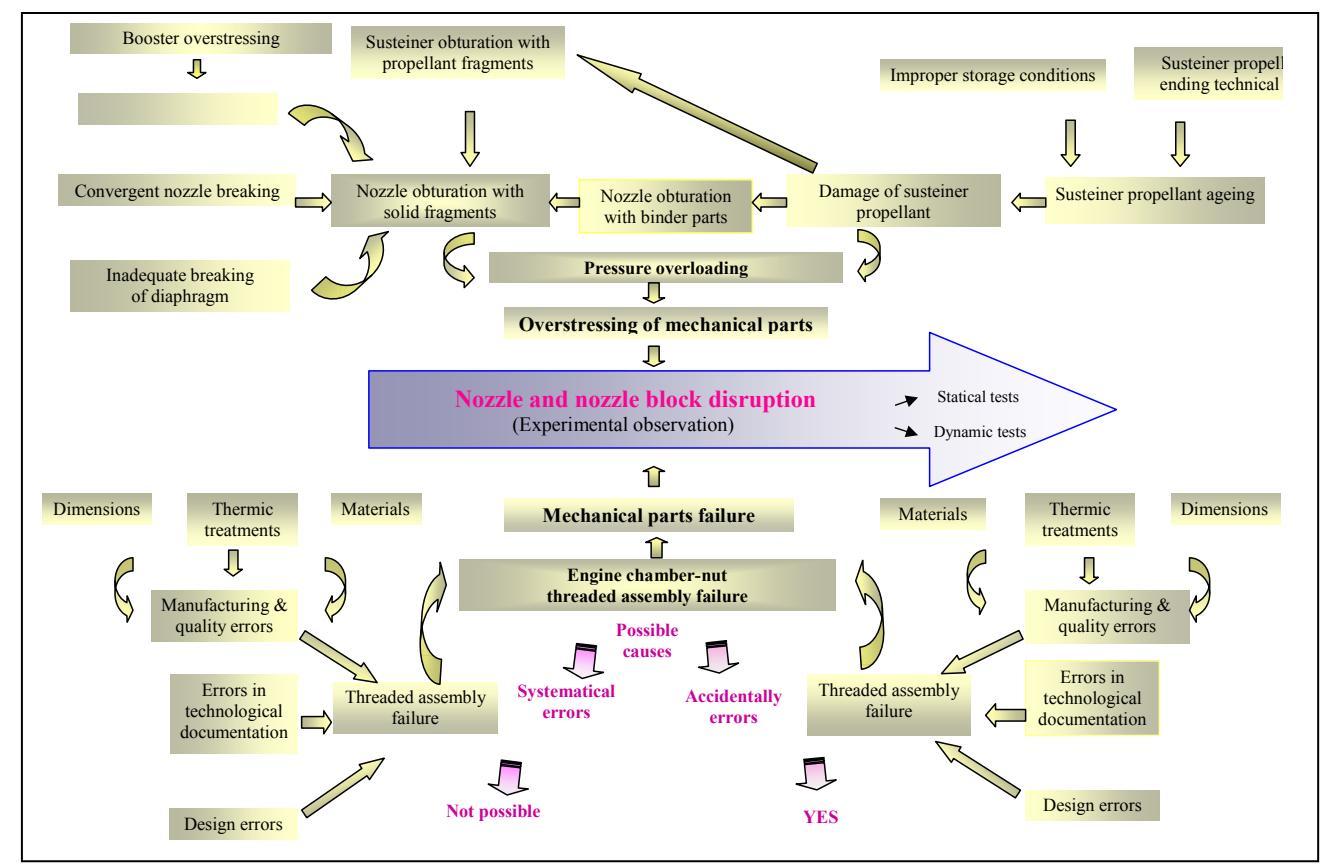
#### Fig.1 Ishikawa diagram

All possible causes were identified, investigated and synthesized in an cause – effect diagram, known as Ishikawa diagram, in combination with an multiple causes diagram, as shown in Fig.1.

The possible causes were separated in three major groups, as follow:

• Causes related to the design process, which could be errors in calculus and execution documentation, or errors in technological documentation;

• Causes related to the fabrication process, which could consist in dimensional (measuring) errors, thermic treatments errors or material errors (hide structure errors);

• Causes related to manipulation, transport, storage conditions or maintenance, etc.

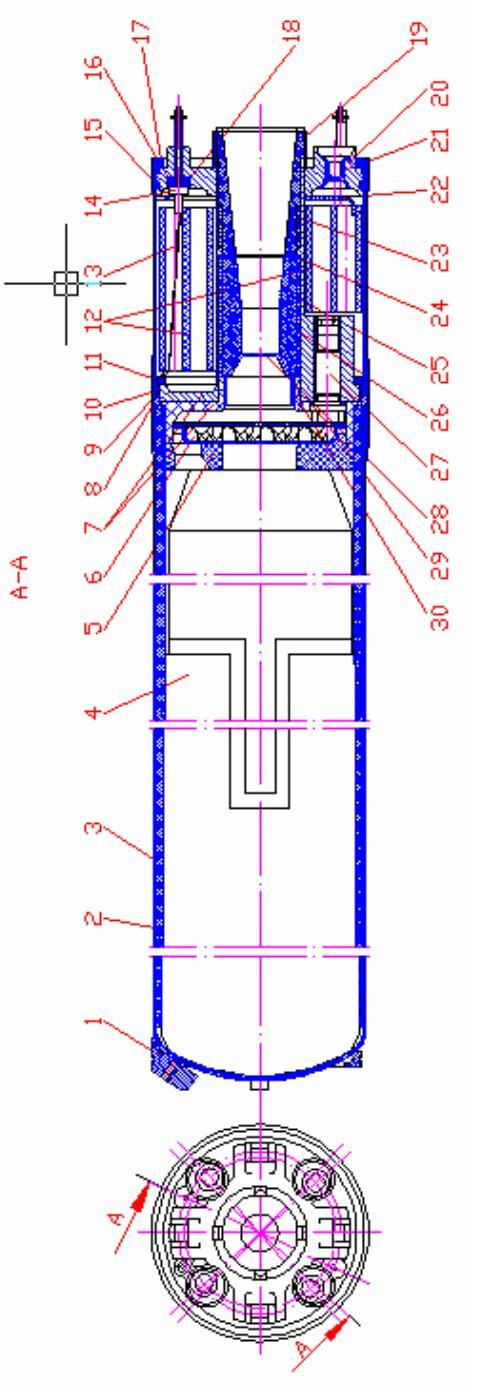
For a better understanding of terms in use and functional principle, the engine scheme is presented in Fig.2. First of all, after a minutious inspection focused on possible wrong exploitation, manufacturing, assembling and testing errors and which inspection included parts and subassemblies analysis, nothing bad were discovered.

Further, during the analysis of rocket fragments after engine functioning, an interesting observation appeared. It was the idea that nozzle block separation was caused due to elastoplastic failure of threaded assembly between nozzle block and engine chamber. The hypothesis confirmation raised from several findings after the dimensional analyze of deformed fragment's shape, as follow:

• In threaded assembly parts the material failure limit was not reached. The material kept it's continuity and integrity and no cracks observed;

The thread does not look as failed by shearing;

• The thread shows local plastic deformations, due to relative displacements, which consist in edge's rotunding and modification of thread side's angle;

• The engine chamber shows remanent radial deformations in threaded assembly area, which values are the upper limit in the ending section. Thus, the exterior diameter of engine chamber reached an increasing values of 0,4 mm / diameter;

• None thermic influence in threaded assembly area was identified, due to burning gases action.

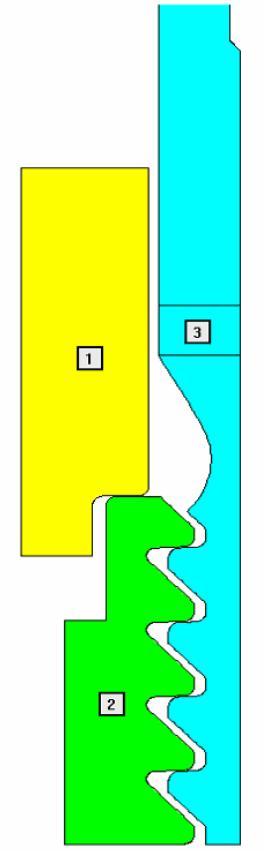
Fig.3 Nozzle block – rocket chamber assembly 1 – nozzle block, 2 – nut, 3 –burning chamber

For the threaded assembly functioning, dimensional cases were assigned. One of them are in concordance with the product technical documentation, while the others were altered with shape and dimension deviations. The threaded assembly is shown in Fig.3, while the situations analyzed are presented in Fig.4. All these cases were submitted to normal, accidental and destructive loadings. The material properties were considered the same as in technical conditions from the execution drawings.

• More restrictive tolerance conditions are needed when fastening the engine chamber and assembling nut;

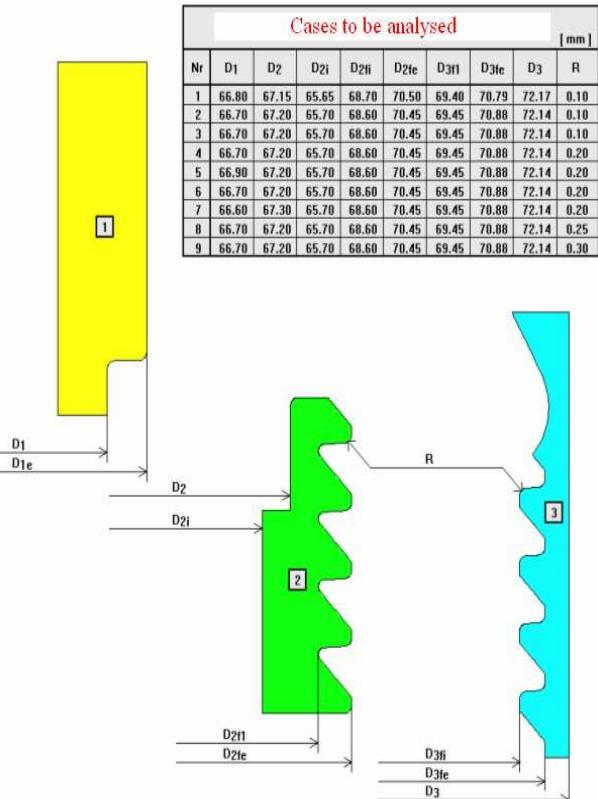
Fig.4 Assembly dimensional variants

• If threaded assembly is made in accurate technical conditions, even it the worst pairing situation the engine withstands higher pressures than prescribed;

• The most important negative effect on assembly stability is represented by the top edge's rotunding or chamfering.

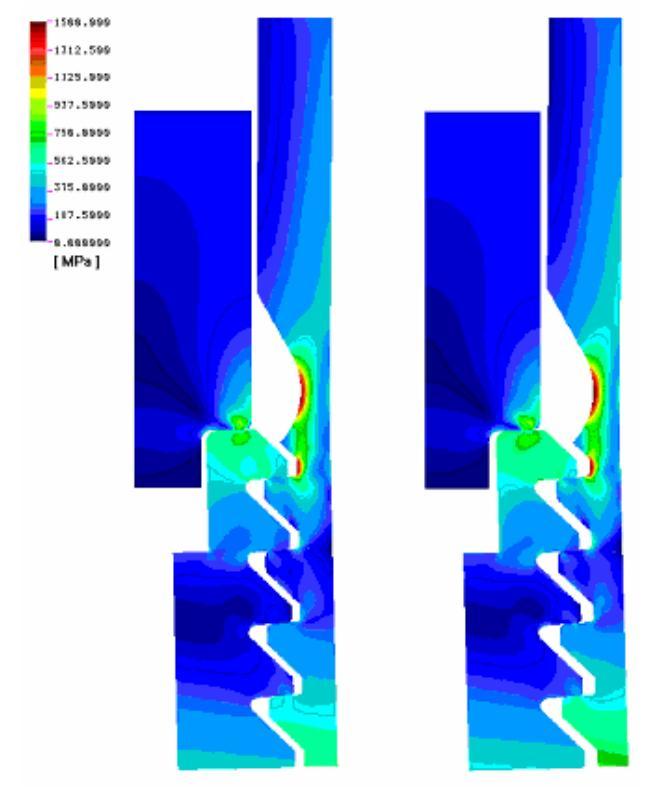
Fig.5 The effective stress threaded assembly for first and second variants

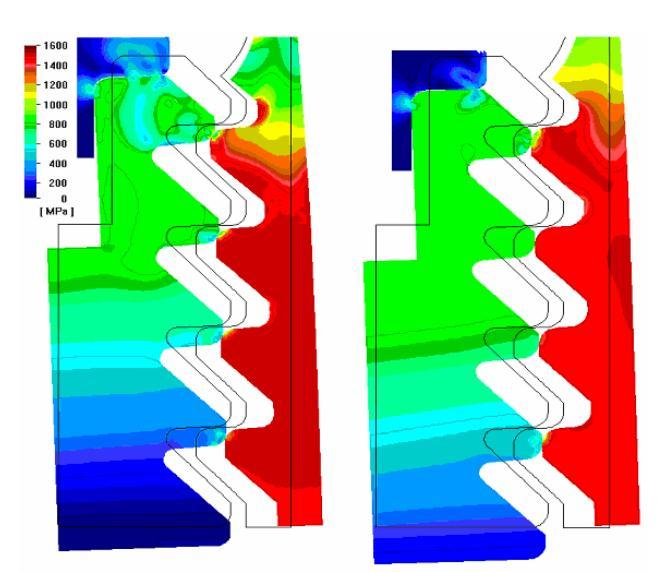
Fig.6 The effective stress threaded assembly for sixth and eighth variants

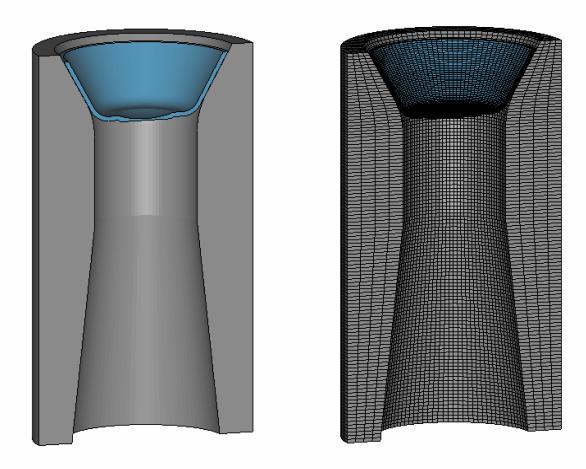
Fig.7 Nozzle – diaphragm assembly All functional cases were submitted to an LS-DYNA analysis for all loading period, when the applied pressures varies from 0 to a maximum of 400 bar, even if in real tests the diaphragms gave up at lower pressure values. In all cases were observed the most important parameter which influences the pressure regime inside the engine. This parameter is the diaphragm breaking pressure. The deformed shapes are presented in form of breaking modes in Fig.8.

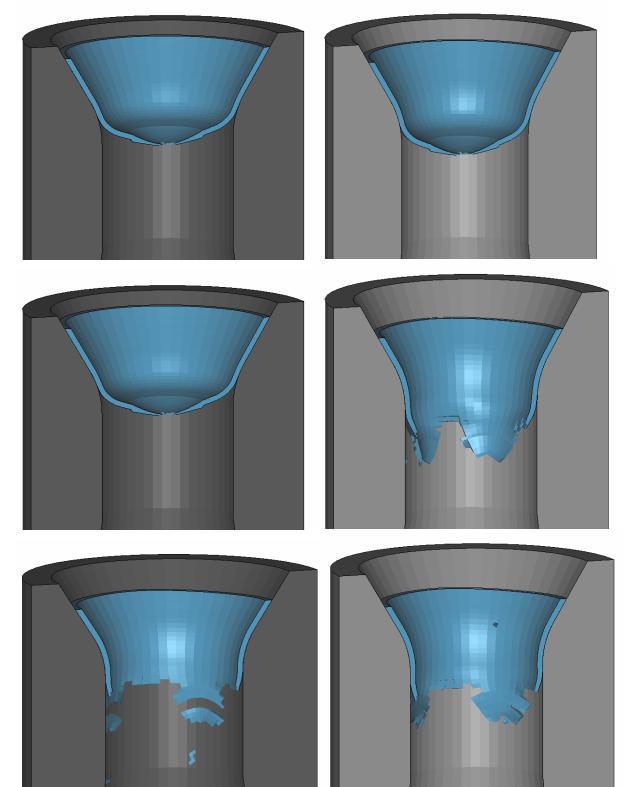
Fig.8 Breaking modes of free diaphragm Left column represents different pressure loadings with quasi-static evolution, while in right column the same pressures are in dynamic evolution.

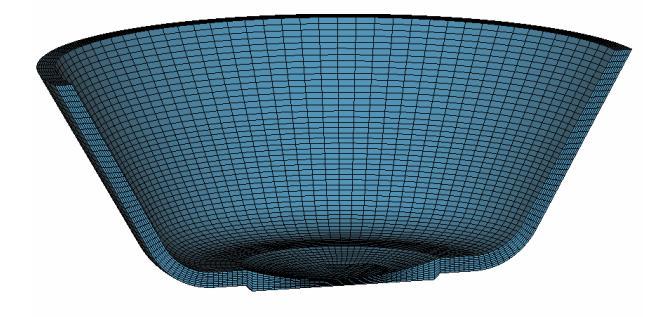
Fig.9 Detail of nozzle - diaphragm assembly

By results analyzing process, was pointed out that best functioning behavior is met when using a bold diagram, as shown in Fig.9.

• Replacing the initial nozzle diaphragm with a bold one, including a bursting shape;

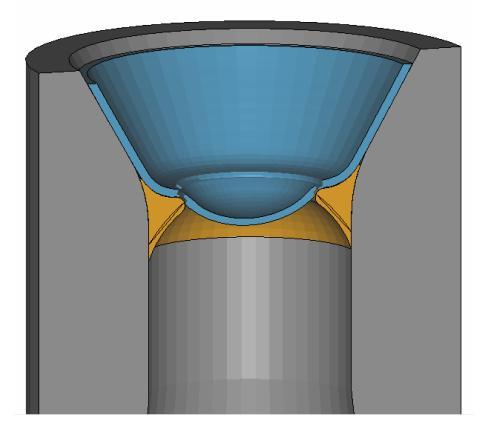
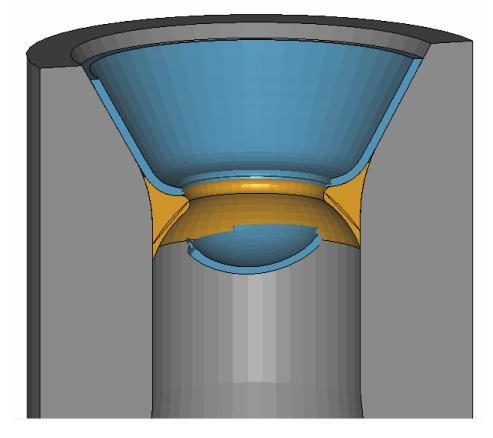
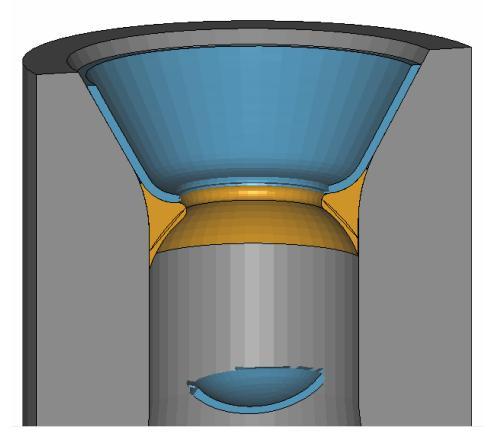
In the case of welding diaphragm, which means there is a firm contact between diaphragm and nozzle surface, it's behavior is totally different, as shown in Fig.10. Due to bold feature on the diaphragm, a cap is cut off when pressure reaches the proper value and rocket engine has a good functioning.

Fig.10 Cap forming from the diaphragm

• More restrictive conditions when sticking diaphragm on the nozzle convergent surface.
