Root-Cause Analysis of Transformer Failure Scenario at Power Sub-Station

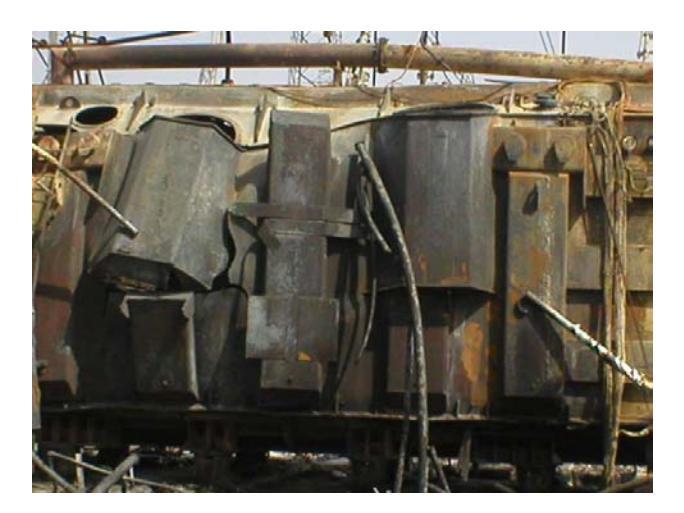
The 400/220 sub-station has been commissioned near about 1998 with the transformation capacity of 1260 MVA. Among the three transformers operating in sub-station, one with rating of 315 MVA failed in year of 2013.

Fig.2 damaged transformer.

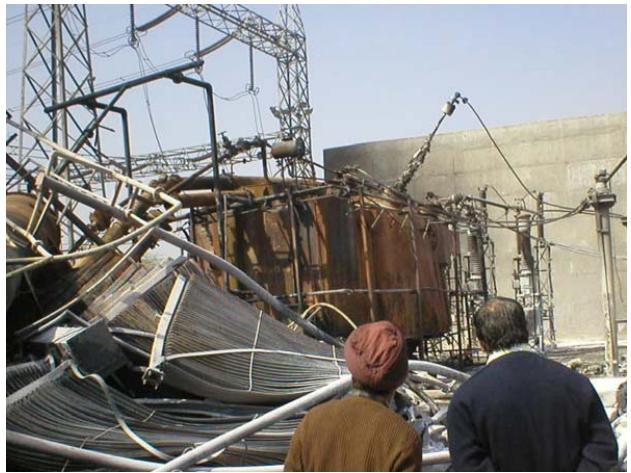
Fig.3 brunt transformer

In initial inspection, we had seen brunt transformers. Different parts of transformers consisting of bushing, tank, winding got damaged due to fire. Along with transformer parts surge arresters, isolator, current transformer and many other equipments of sub-station got damaged. Relays affected due to failure are listed below:

Buchhloz relay, OLTC buchhloz, differential relay, and REF relay etc.

As per available data records, no clear picture appears for failure cause. But as concerned to data history, transformer is kept out of services for almost seven years during 1993 to 2000. The transformer at site is generally filled with nitrogen under prescribed limit of pressure for not more than 5 to 6 month. If long storage cases occur transformer should be filled with oil and oil to be filtered at regular interval. Here long storage of transformer may result in ingress of moisture throughout insulation of winding and hence result in insulation failure of transformer.

Restoration is not possible as transformer is completely brunt and has to be replaced.
