Artificial Neural Networks Used for Failure Diagnosis in ZnO Arresters

ESTÁCIO TAVARES WANDERLEY NETO, EDSON GUEDES DA COSTA

MARCELO JOSÉ DE ALBUQUERQUE MAIA
Companhia Hidro Elétrica do São Francisco - Chesf
Av. Delmiro Gouveia, 333. Bongi. Recife - PE
BRASIL

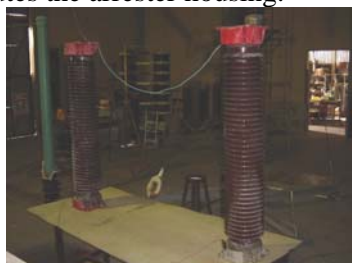
Fig. 3 – Arresters covered with salty pollution.

For the failure tests, the arrester was put in to a salty fog in order to simulate the presence of a more severe pollution on its surface. On of the consequences of the salty fog was the appearance of superficial discharges on terminals of the arrester. This discharge probably was resultant from the presence of water drops the neighborhoods of the terminal. The thermal images indicated a greater heating in the proximities of the terminals and in the downer part of the arrester. As though there is a lower heating in its upper portion. A possible explanation is that the pollution was concentrated in the downer region of the arrester, causing partial discharges there. Other possibility is the increase of superficial currents in the upper region of the arresters which

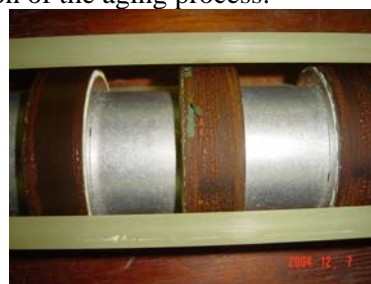
Fig. 4 – Varistors degraded by excessive heating.

Varistors degradation can be resulted from its natural ageing, from its premature ageing due to severe electrical surges or its breaking [8]. However, in many cases, when a varistor failure diagnosis is done, vestiges of some factors that can have caused its failure are found. Premature degradation of varistors is a factor that can contribute to the occurrence of thermal runaway (Fig. 4). There are still some external aspects that should be considered when evaluating the premature aging of the varistors. Example are the environmental temperature and the entrance of humidity. It is known that these factors favor the increase of the leakage current and, as a consequence, there is an increase of temperature and acceleration of the aging process.

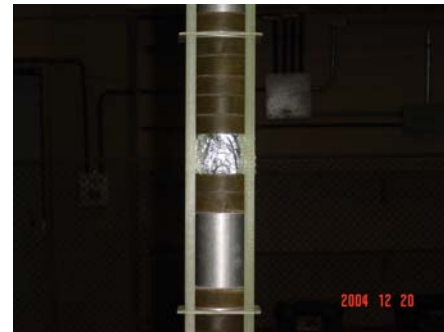
Fig. 5 – Short-circuited varistors in an arrester column.

For the execution of failure tests conductive materials were used to short-circuit some varistors located in different positions along the arrester active column (Fig. 5). This situation simulates a problem in varistor that would cause an excessive current conduction for it and, as consequence, an alteration in the voltage distribution. As results, a decrease in the heating on the region of the short-circuited varistors could be noticed. The explanation is the fact that these varistors are not presenting thermal dissipation like they used to present before they were short-circuited.

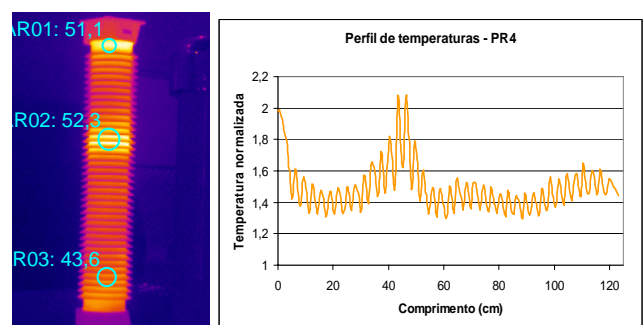
Fig. 7 – Thermal image and thermal profile graph of arrester in Fig. 6 after humidity was introduced in its inner region.

As an example of the results obtained with the failure tests, Fig. 6 depicts the thermal image and profile of an arrester the way it was received from Chesf, while Fig. 7 shows the thermal image and profile after humidity inclusion. A fast comparison between the thermal images is enough to indicate the change caused by the humidity. An analysis of the thermal profiles indicates more precisely the level and location of the alterations in the arrester thermal behavior.

The humidity example, shown behind is a case where a simple eye analysis is able to indicate the presence of the failure. In other cases, like a short circuit in a varistor located in the middle portion of the an eye inspection may not be enough to percept the failure. In this case, a computational processing,
