# Glass fibre reinforced textile composites strengthening solutions for masonry arches

*Abstract:* Masonry arches are frequent components of the monumental buildings, many of them belonging to the historical heritage. Masonry as a structural material has high compressive strength and versatility, in achieving different architectural shapes. Since the tensile strength of masonry is very low, under certain loading conditions, the masonry arches are vulnerable to cracking and to various failure mechanisms. Previous theoretical and experimental studies have proven that the use of textile glass fibre reinforced polymer (GFRP) composite materials has favorable effects upon the structural behaviour and the load bearing capacity of the structural elements. In this paper the results of an extensive experimental program on the structural behaviour and failure mechanisms of unstrengthened and strengthened masonry arches are presented. The experimental results describe the mechanical behaviour of circular masonry arches under vertical and horizontal loadings. The strengthening scheme has been conceived in two phases, on one side only and on both sides of the arch, with the connecting strips m

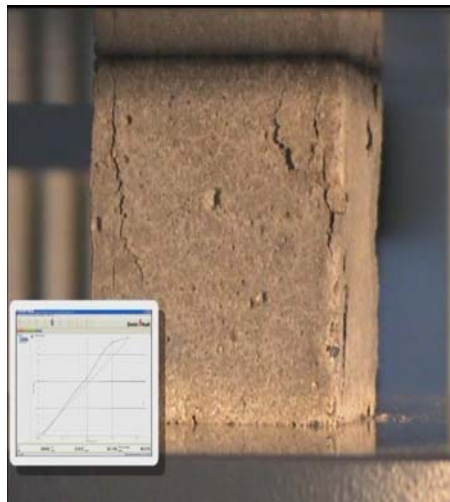
Fig. 2 Compression test on mortar specimen

The experimental model has been made of masonry with normal bricks and mortars. Prior to construction of the model, preliminary tests on the material properties have been carried out. Tests have been performed on brick sample Fig. 1, mortars cubic test specimens Fig.2, block of bricks Fig.3 and bonding between GFRP strips and masonry block Fig.4.

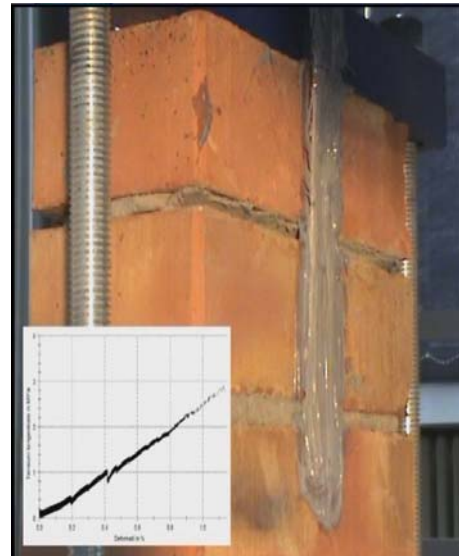
Fig. 4 Bonding test GFRP strip-masonry block

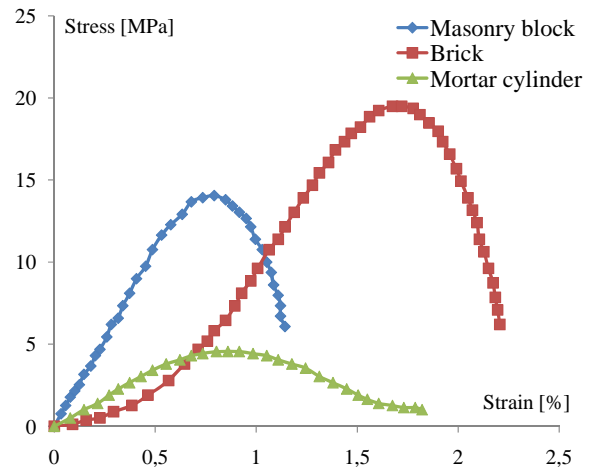
A comparative illustration of the experimental curves is presented in Fig. 5, for brick specimen, mortar sample and masonry block.

Fig. 5 The stress-strain curves for the materials utilised at the experimental arch

The values of the properties determined on the experimental tests have been utilised in the numerical modelling of describing the structural response of the unstrengthened masonry arch subjected to vertical and horizontal loading.

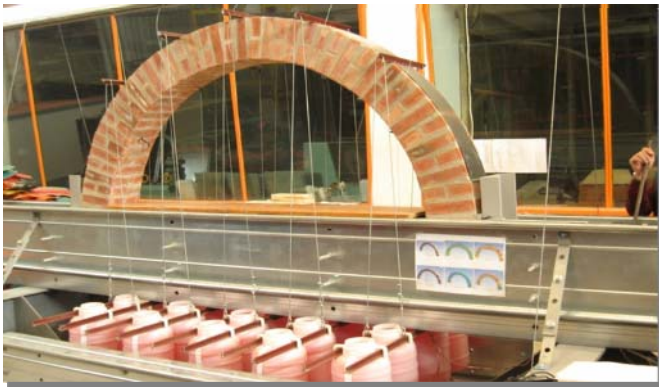
The arch has been conceived as a two hinged one; on the right hand side a horizontal load has been applied by means of a hydraulic jack [5]. A load cell has been utilized to record the horizontal load magnitude. Gravitational loads have also been applied using five

loading positions with water filled recipients hanged as shown in Fig.6 to simulate the effect of service loads.

Fig. 6 The vertical loading of the unstrengthened arch

The unstrengthened masonry arch has been firstly tested to identify the possible failure loads and failure mechanisms under vertical and horizontal loads, Fig.6 and Fig.7. Common 240x115x63mm bricks and a common mortar, normally utilized in masonry works have been used to make the sample arch.

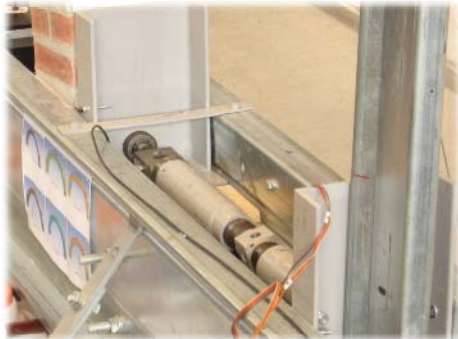
Fig. 7 Horizontal loading system

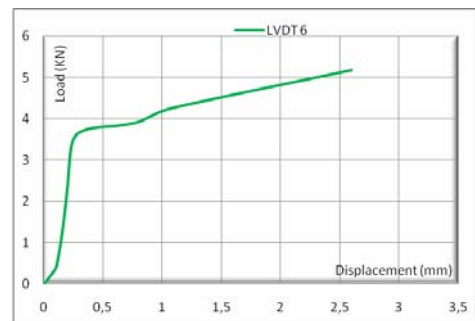
A force displacement curve recorded at the level of LVDT no. 6 is illustrated in Fig. 10.

Fig. 10 Structural response of the unstrengthened arch

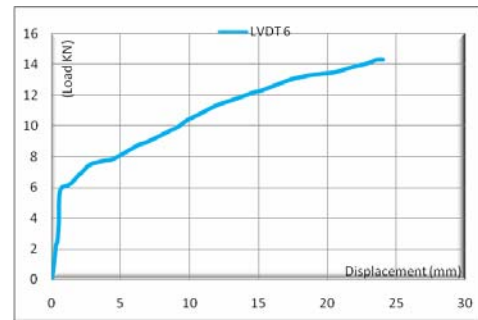
Fig. 12 Load versus lateral displacement of the FRP upper side strengthened masonry arch

The horizontal force has been applied until the load carrying capacity of the arch has been reached corresponding to a horizontal force 14.2 KN and a horizontal displacement equal to 24 mm. At this load the upper side strengthened arch failed and a new plastic hinge appeared Fig.11. Some specific particularities of the one sided strengthened arch have been noticed:

- the strengthened arch behaved in a similar manner to the unstrengthened arch up to a horizontal displacement level of 1mm;
- the strengthened arch had a more convenient deformability;
- the active contribution to the structural response of the FRP composite strip has become obvious after the tensile stresses surpassed the tensile strength of the masonry;
- the load bearing capacity of the strengthened arch was about 3 times higher than that of the unstrengthened one;
- a visible failure occurred by debonding the composite strip from the masonry.

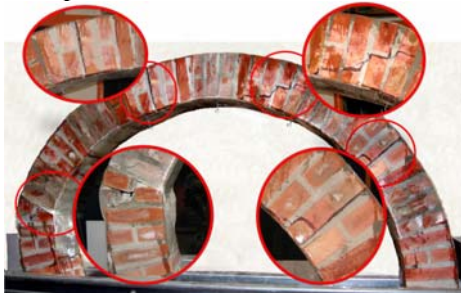
capable of resisting all external loading. After surpassing the strength of the masonry, the composite strip enabled the arch to have a more appropriate deformability up to an important horizontal load level equal to 26 KN and a corresponding horizontal deformation of 58 mm. The failure mechanisms corresponding to this loading case consist of four different plastic hinges, Fig. 13. A structural response is given in Fig.14 in terms of force and lateral displacements.

Fig. 13 Failure mechanism

of the double sided FRP strengthened masonry arch

- an improvement of the overall structural response of the double sided strengthened arch has also been identified by formation of four plastic hinges;

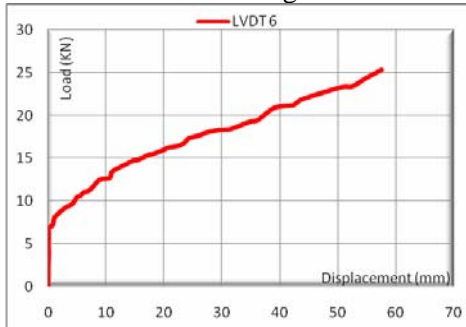
Fig. 14 Structural response

of the double sided FRP strengthened masonry arch

- the load carrying capacity of the double sided strengthened arch increased up to 26 KN (compared to 14.2 KN in case of single side strengthened arch);

- the deformation capacity of the framing system has also increased from 24 mm horizontal displacement (for the single sided strengthened arch) to 58 mm (in case of the double sided strengthened arch);

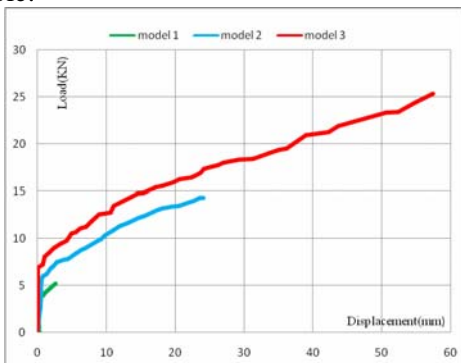
A synthetic comparison regarding the three testing cases, for the un-strengthened, the one sided strengthened and the double sided strengthened arch is presented in Fig. 15. The curves give a comparative study for the structural responses of the cases mentioned before. The contribution of the composite strengthened system is obvious and the efficiency of using FRP composites in masonry arches strengthened solutions is undeniable.

Fig. 15 The load-displacement curves for the main studied cases: model 1 – un-strengthened arch; model 2 - one-sided strengthened arch; model 3 – double sided strengthened arch

The loss of the load bearing capacity has occurred by the debonding of the upper side placed glass woven roving composite reinforcement.
