Practical Application of the New Digital Snow Load Map

Abstract: -This paper turns attention to the collapse analysis of roof steel platform structure. Collapse occurred in the process of extreme winter conditions. Influence of snow conditions as well as subsequent effects are discussed in this paper. The application of a new digital ground snow load map for the area of the Czech Republic is introduced.

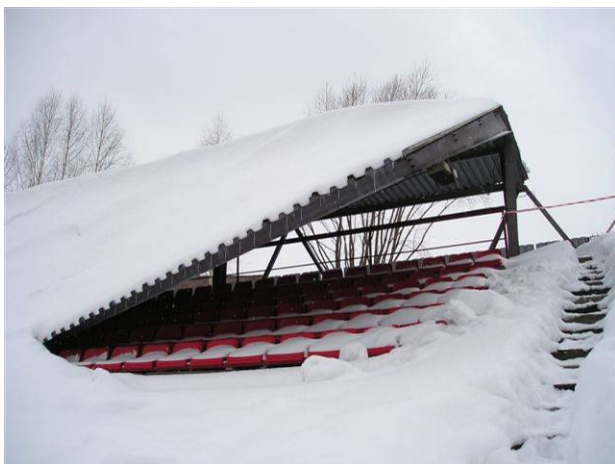
The paper describes and discusses the factors that must be considered when investigating the causes of the accident associated with the building at the time of extreme climatic conditions. Increased attention is paid to the precise determination of snow load. The problem is explained using the example of an accident on the stands roof of the football stadium (see Figure 1) [1].

Fig. 1 View of the collapsed roof of the football stadium

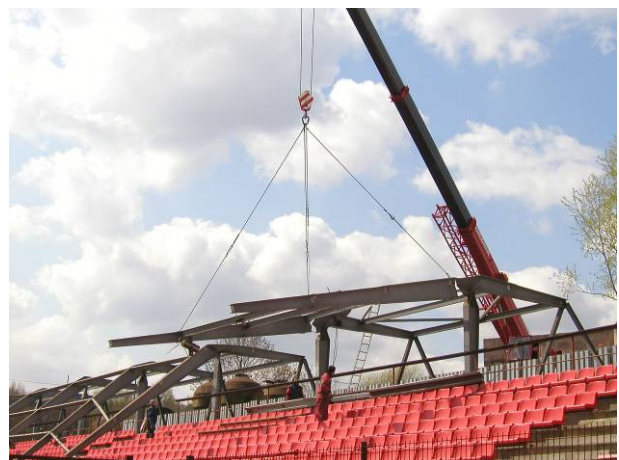
The stands supporting steel structure of the roof of the football stadium collapsed in March 2005, when the weight of snow caused a deformation of the supporting structure of the stand roof lined with consoles so that the roof fell onto the stands' seating (see Figure 2).

A forensic examination of the collapse site was carried out during the gradual dismantling of the structure. The trapezoidal sheets of the roof structure have already been dismantled, and disassembled trapezoidal sheets were placed on temporary landfill while the gradual burning of distorted consoles of the supporting structure took place as well as their removal.

Fig. 2 View of the collapsed structure after dismantling of the coverings

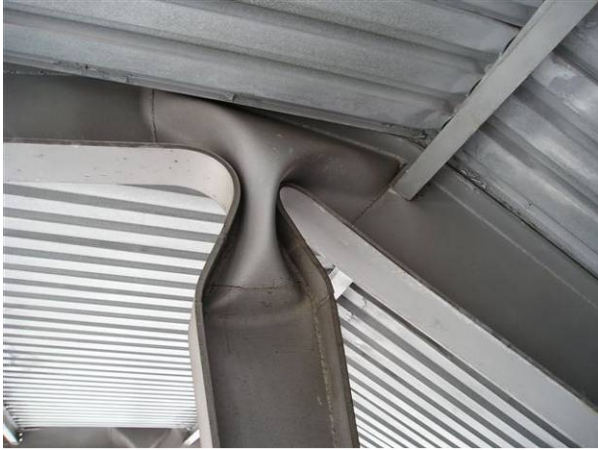
Authors' visit to the accident site showed that the collapse was caused by swelling and subsequent plastic deformation of steel uprights of the welded I-girder at the connection of the stands' girders lined with consoles [2, 3] – see Figure 3 and 4.

Fig. 3 Detail of the damaged joint in the part of structure with covering

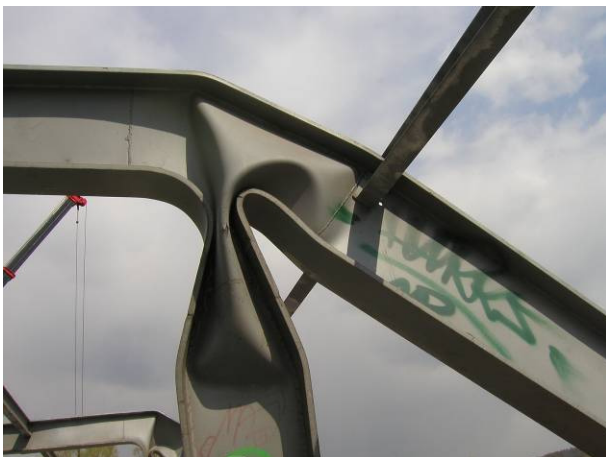
Fig. 4 Detail of the damaged joint in the part of structure without covering

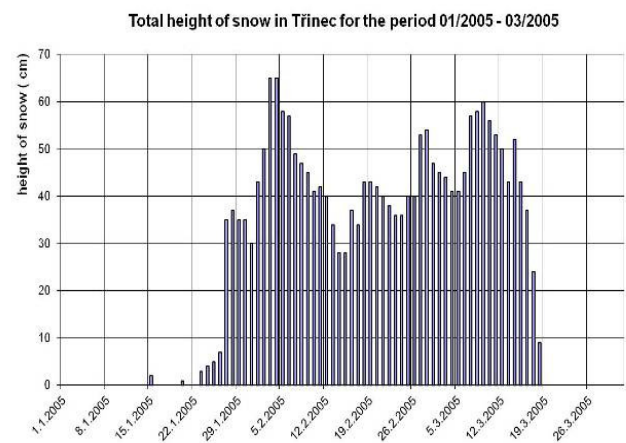
There is a climatological station of the Czech Hydrometeorological Institute (CHMI) near the collapsed structure. Based on CHMI data (Figure 6) it can be stated that at the time of the accident snow water equivalent in the structure area was approximately 135 mm, which corresponds to a snow load on the ground of 1.35 kNm^{-2} . The height of snow cover was approximately 60 to 70 cm. The data provided by CHMI were confirmed by simplified measurement on a site of the accident.

Fig. 6 History of snow height in the assessed locality
