Influence on the bearing capacity of a large door and window cut-out opening in Precast Reinforced Concrete Wall Panel

Abstract: - The authors of this paper are presenting an experimental study regarding the influence on the seismic behavior of a large door and window cut-out opening (EL2) in a Precast Reinforced Concrete Wall Panel (PRCWP). The experimental specimen was subjected to in-plane cyclic loading in order to simulate the shear behavior and not the flexural one. The lateral loads will be applied in displacement control while two vertical loads simulating the load of a five story building will prevent the rocking effect of the test specimen. The measurement will include the lateral force, the drift and the efforts in the reinforcement up until failure. The primary goals were to provide information about the shear behavior of Precast Reinforced Wall Panels (PRCWP) weakened by a large door and window cut-out opening and to compare the results with a solid element tested in a previous campaign to see how much of the initial bearing capacity is lost due to the cut-out opening.

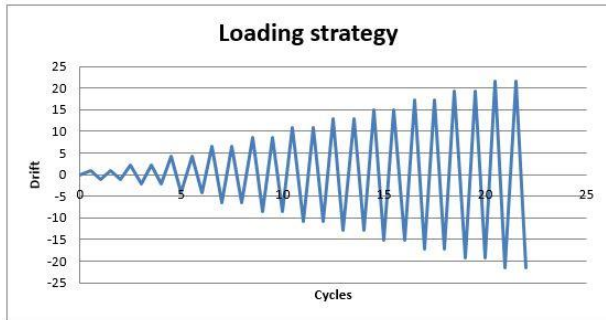
Fig.7 Loading strategy

The tested specimen was subjected to quasi-static in-plane cyclic loading and pseudo-constant axial loads. The axial loads were kept constant at 220 kN to simulate the real building loading and were only increased to counter the element's rocking rotation tendency, for each step of the loading strategy the axial load was increased by 100 kN if the element

had a 1 mm vertical displacement. The lateral (seismic) loading strategy was defined in terms of constant displacement control of 0.1 % drift ratio, the specimen having a 2150 mm height the displacement control was in increments on 2.15 mm. Therefore the displacement levels were as follows: 2.15 mm, 4.3 mm, 6.45 mm, 8.6 mm, etc. respectively 0.1%, 0.2%, 0.3%, 0.4%, etc. For each displacement level two cycles were made, when the specimen had a 20% drop in lateral load bearing capacity the failure criteria was fulfilled.

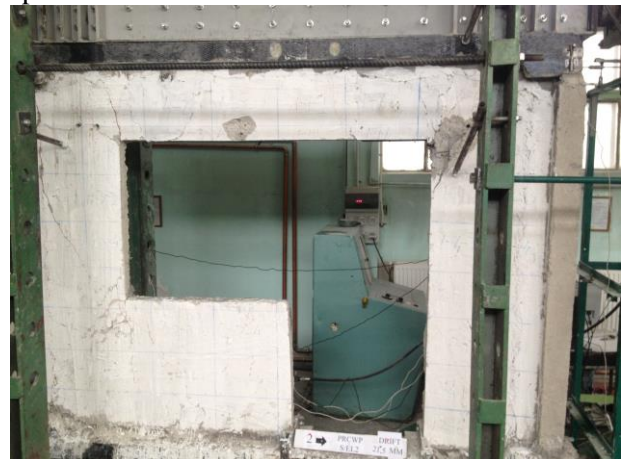
Fig.9 Tested element

specimen's behavior was characterized by the appearance of cracks, mainly in the top corners of the opening and in the left pier. In the second part of the experiment the reinforcement started yielding at 19.35 mm with a horizontal force of 251.5 kN and vertical loads $N_{1left}=433$ kN and $N_{2right}=260$ kN and large diagonal crack appeared in the left pier. The element had a ductile behavior losing more than 20% of its horizontal (seismic) load bearing capacity at 19.35 mm (0.9%) drift. In Fig.10, Fig.11, Fig.12 the details regarding the failure of the specimen are presented and Fig.9 shows the element after testing. It can be seen that the concrete crushed at the top right corner of the door opening and at the bottom left corner of the window opening.

In the top left corner of the widow opening a large crack can be observed extending up to the top of the tested specimen and also in left pier the large diagonal crack extending from the top left corner and slicing through the entire left pier all the way to the bottom end of the element is visible. This large diagonal crack lead to the loss of the bearing capacity and inevitably to the failure of the specimen.

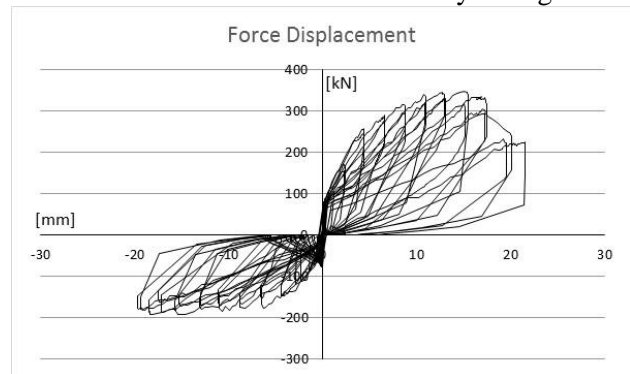
Fig.13 Force displacement diagram

The tested element reached a maximum horizontal (seismic) force of 335 kN at a drift level of 17.2 mm in the first cycle corresponding to 0.8% while the vertical (gravitational) loads were $N_{1left}=453$ kN and $N_{2right}=340$ kN. After reaching its peak load bearing capacity the specimen lost 15% of its load bearing capacity reaching a maximum horizontal (seismic) load of 285 kN at 19.35 mm (0.9%) in the first cycle, but the failure criteria was still not met, therefore we went further with the testing and in the second cycle at the same above mentioned drift level the element only managed to reach a horizontal (seismic) load of 220 kN and the vertical (gravitational) loads were $N_{1left}=400$ and $N_{2right}=304$ Kn meaning a loss of 35% of its load bearing capacity. In Fig.13 the force displacement diagram is presented while in Fig.14 the strain displacement diagram for the strain gauge placed on

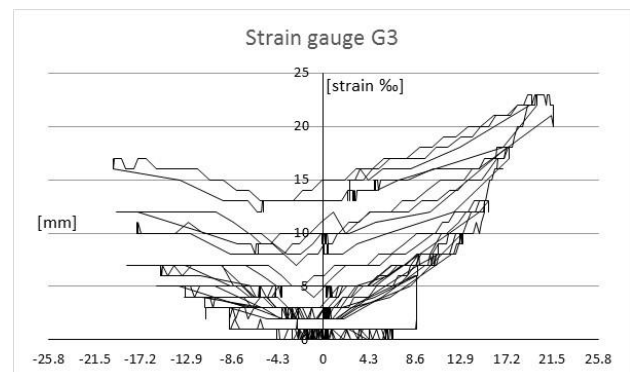
Fig.14 Strain gauge G3 placed on reinforcement

the reinforcement. We observed that only one of the monitored reinforcements reached its yielding limit.

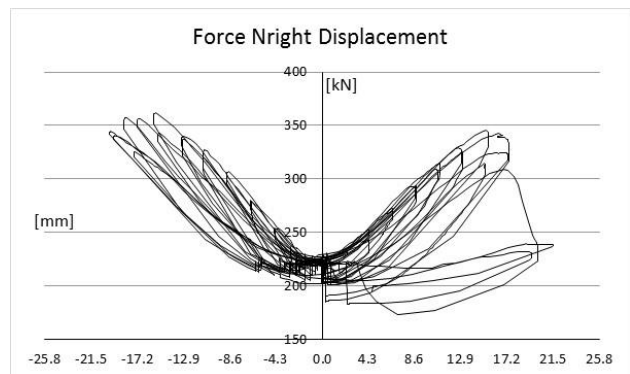
Fig.15 Force displacement diagram for the right vertical force

The below two diagrams depicted in Fig.15 and Fig.16 present the force displacement diagrams for the two vertical (gravitational) left and right forces and the drift. The maximum value for the right force was 361 kN obtained on negative drift and for the left force was 452 kN obtained on positive drift.

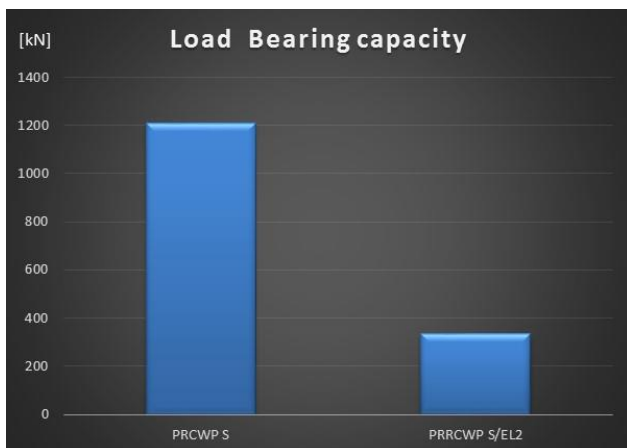
Fig.17 Difference in load bearing capacity

The purpose of this paper was to observe the effects of a large door and window cut-out opening in a Precast Reinforced Concrete Wall Panel (PRCWP). The solid specimen tested in a previous campaign [1] had a maximum unexpected later load resistance that exceeded the capacity of the hydraulic equipment so the solid wall was not loaded beyond 1210 kN and 0.6% drift ratio. In Fig.17 the difference between the two walls bearing capacity is presented and it can be clearly seen that the tested specimen with the large door and window opening cut-out had under 28% of the solid wall bearing capacity. The maximum drift ratio achieved by the PRCWP S/EL2 was increased by 50% as shown in Fig.18

In conclusion it can be said that the implications of cutting out a large door and window opening into a solid Precast reinforced Concrete Wall Panel (PRCWP) are very severe, the behavior of the two elements are different because of the large difference in rigidity. The specimen with the opening cut-out had a much higher drift ratio making it more ductile than the solid element. Such a procedure on a PRCWP can only be made if proper retrofitting measurements are applied on the element after the cut-out of the opening.
