R&D in TALOS High Voltage Test Station- Assessing aging and performance of polymer insulators

D. PYLARINOS

K. SIDERAKIS

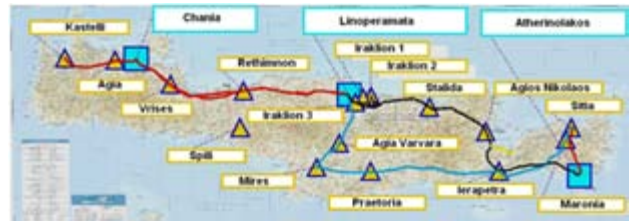
Fig. 1. The power system of Crete. Squares denote step-up substation/power plants and triangles denote step-down substation

As shown in Figure 1, the majority of all substations is located near the coast. Historically, high pressure water washing was mostly employed to clear the insulators and suppress the pollution problem [8, 19-23, 26]. It should be noted that as live washing is prohibited under Greek law, that meant an added cost during the substations' design and construction in order to be possible to wash all insulators without power interruptions [8, 19-23, 26]. An added issue was the cleaning schedule: if washing was scheduled late, a high risk occurred. If washing was scheduled early a new washing could be required before the end of the dry period which meant a significant added cost. Considerable costs also occurred due to the fact that the island's system is isolated. This meant that when a part of a substation was put out of service, supply interruptions could occur [8, 19-23, 26]. Further, in some cases (e.g. Linoperamata) when cheap base units were turned off, expensive gas turbines had to be used in their

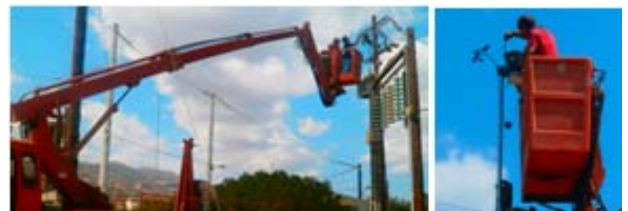
Fig. 5. Installation of the weather station on top of the pollution measurement arch

consisted of three bays: one for 150kV post insulators, one for 150kV suspension insulators and one for 21kV suspension and post insulators (Figure 2). TALOS is also equipped with a dedicated facility capable of operating at variable heights where non energized insulators are suspended in order to acquire comparative pollution measurements between insulators of different type, material and profile. A 3D model of the Test Station is shown in Figure 3 whereas photos of the arch used for comparative pollution measurements are shown in Figure 4. A dedicated weather station has been installed on top of the pollution measurements arch (Figure 5) capable of recording temperature, wind, humidity, rain and UV radiation readings.

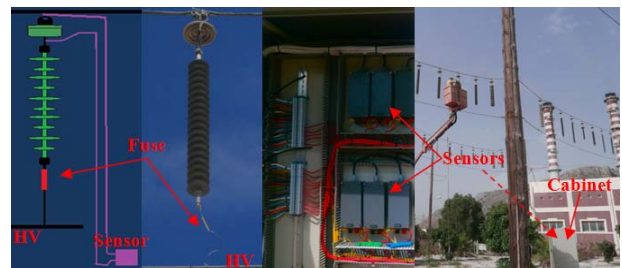
Fig. 6. A drawing of the basic leakage current measuring installation and photos from the actual installation in TALOS High Voltage Test Station

The leakage current measurement is acquired by using a stand-off insulator to lead the current to a hall sensor. Currently a DATAQ DI-722-32 DAQ is installed capable of monitoring 32 samples with a burst sampling rate of 50kHz. Added DAQs to be installed will provide the capability of monitoring over 100 insulators. An explosive fuse is used to protect the leakage current monitoring equipment and to enable the disconnection of a particular insulator, e.g. in case of a flashover, without interrupting the supply to the other insulators. Sensors and measuring devices are housed in a cabinet for protection and ease of access. Drawing and photos regarding the leakage current set-up are shown in Figure 6. All measuring devices (DAQs and weather station) are connected via LAN to a PC housed in the control room. The position of the control room is at the center of the test station as shown in Figure 3. Additional photos and data along with a list of related published material and a live weather report can be found in the station's site [18].
