Investigation upon Construction Technology, Operation and Maintenance Procedures for Slabs-on-Ground

ANDREEA-TEREZIA MIRCEA
 Faculty of Civil Engineering
 Technical University of Cluj-Napoca
 15 C. Daicoviciu Street, 400020 Cluj-Napoca
 ROMANIA
 andreea.mircea@bmt.utcluj.ro

The investigation was prepared at the request of the contractor of the concrete pavement made at the platform of an industrial company.

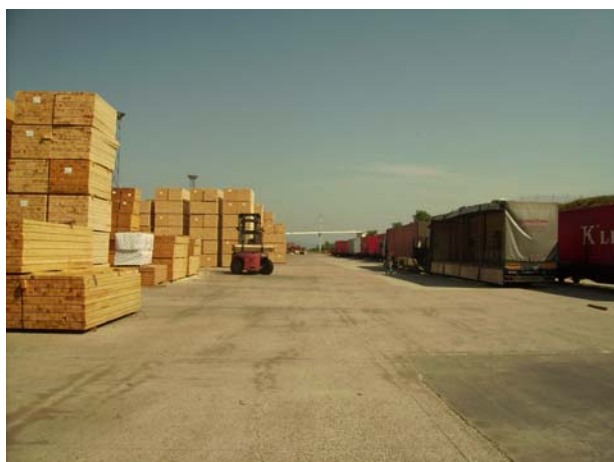
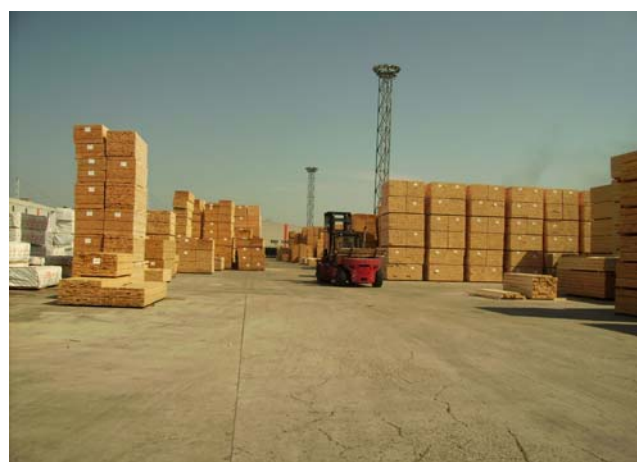
Figure 1. The investigated concrete pavement at the platform of an industrial company

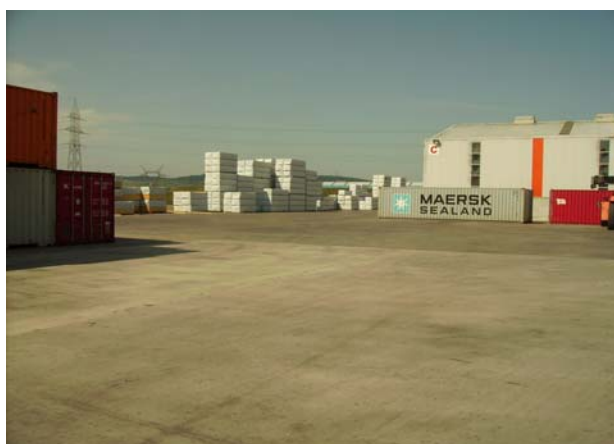
Figure 2. The platform covers around 200 000 m²

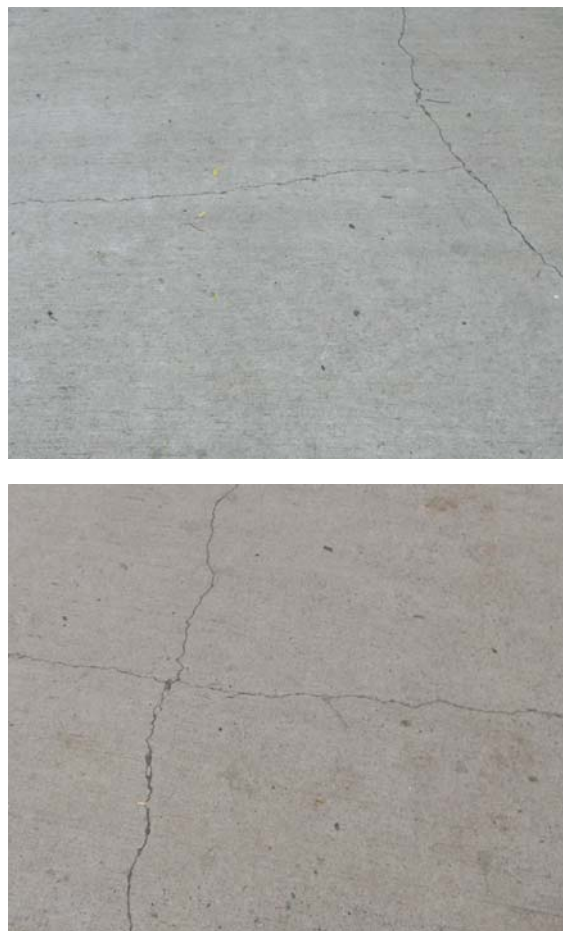
Concrete expands and shrinks with changes in moisture and temperature. The overall tendency is to shrink and this can cause cracking (Figure 3). External restraint to global volume change is provided by the subgrade, while internal restraint is generated between parts of the same element that present temperature gradients, moisture migration and embedded reinforcement. When the tensile stresses induced by the restraint to volume reduction exceed the tensile strength of concrete, the element cracks.

Figure 3. Transverse cracks due to restrained shrinkage

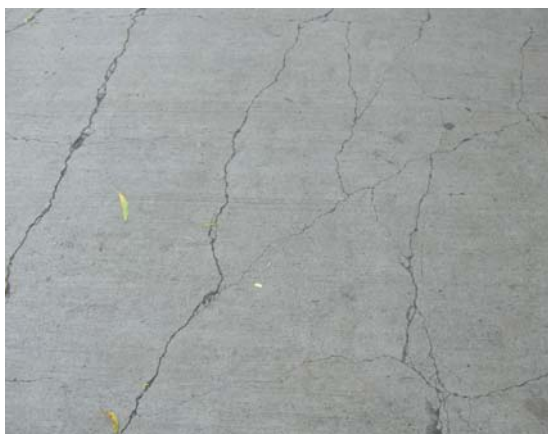
Crazing (map cracking) is a network of fine fissures on the concrete surface that enclose small (12 to 20 mm) and irregular hexagonal areas (Figure 4). Shallow; often only 3 mm deep cracks may occur throughout the panel surface. This type of cracking is caused by restrained drying shrinkage of the surface layer after set (usually apparent the day after placement or by the end of the first week.).

Figure 4. A network of fine fissures on the concrete surface

Some map cracking cannot be seen unless the pavement surface is wet. Visible crazing is somewhat unsightly but generally does not pose a structural problem. However, map cracks do permit water and chemicals to enter the concrete surface, so extensive map cracking may result in long-term durability problems.

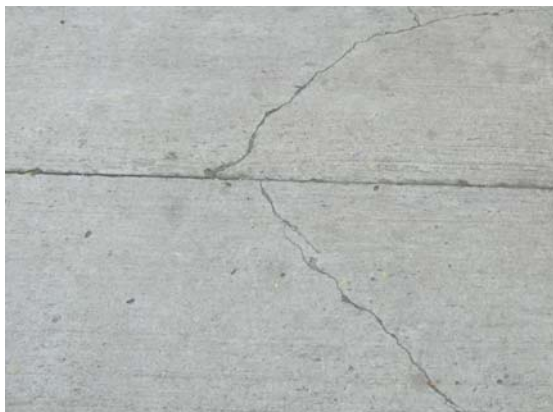
Corner cracks (Figure 5) occur when a pavement carries loads that are heavier than its current strength can support and/or when there is loss of base support. For instance, early loading with heavy construction equipment can cause corner cracking. Furthermore, curled or warped slabs lose base support where the slab lifts away from the grade.

Figure 5. Corner cracks

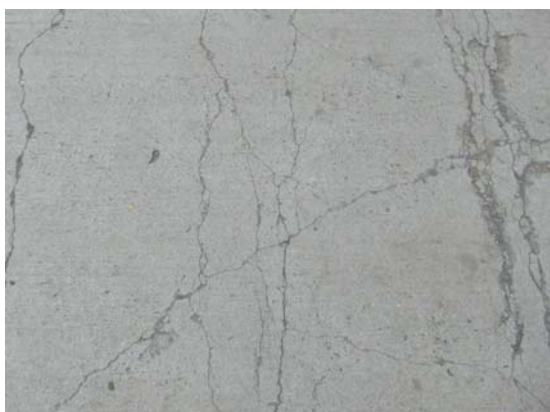
Concrete containing aggregates that are not frost resistant may experience *D-cracking*. Aggregate particles with coarse pore structure may be susceptible to freeze-thaw damage. When these particles become saturated and the water freezes, expanding water trapped in the pores cannot get out. Eventually, the aggregate particles cannot accommodate the pressure from the expanding water; the particles crack and deteriorate. In concretes with appreciable amounts of susceptible aggregate, this freeze-thaw deterioration of the aggregate ultimately results in cracking in the concrete slab, called D-cracking (Figure 6). D-cracking is generally a regional problem caused when locally available, susceptible aggregate is used in concrete. D-cracks are easy to identify. They are closely spaced cracks parallel to transverse and longitudinal joints (where the aggregate is most likely to become saturated). Over time, the cracks multiply outward from the joints toward the center of the pavement slab.

Figure 6. Closely spaced cracks parallel to transverse and longitudinal joints

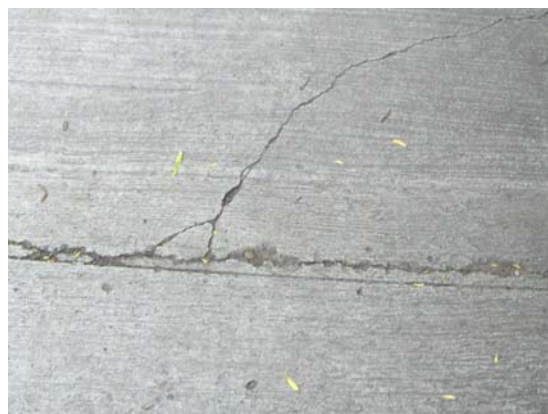
Construction joints not deep enough (Figure 7). In order to limit the frequency and width of random cracks caused by volume changes, the joints create planes of weakness where cracks form.

Figure 7. Saw-cut construction joints were not deep enough, so cracking of concrete occurred in the vicinity

Saw-cut joints have a depth of at least 1/4 of the slab depth or 25 mm. For steel fibre reinforced concrete slabs, the saw cut using a conventional saw should be 1/3 of the slab depth.

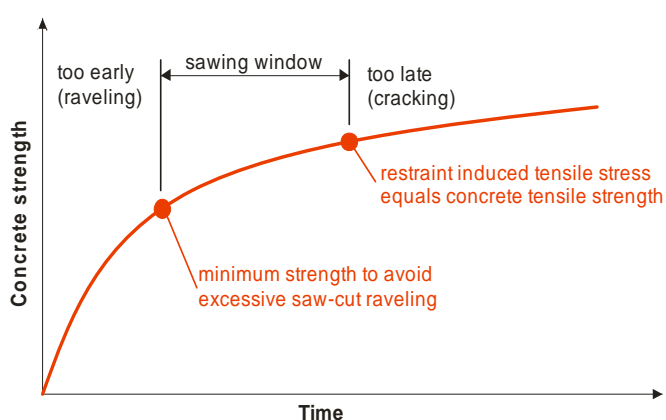
Construction joints sawn too late: Saw-cutting should be performed before concrete starts to cool, as soon as the concrete surface is firm enough not to be damaged by the blade (the resulting jagged, rough edges are termed raveling), and before development of significant tensile stresses in the concrete and random drying shrinkage cracks occur (Figure 8).

Figure 8. Sawing window showing the duration between minimum strength - when it is recommended to avoid excessive saw-cut (raveling) and the moment when restraint induced tensile stress equals concrete tensile strengths (cracking)

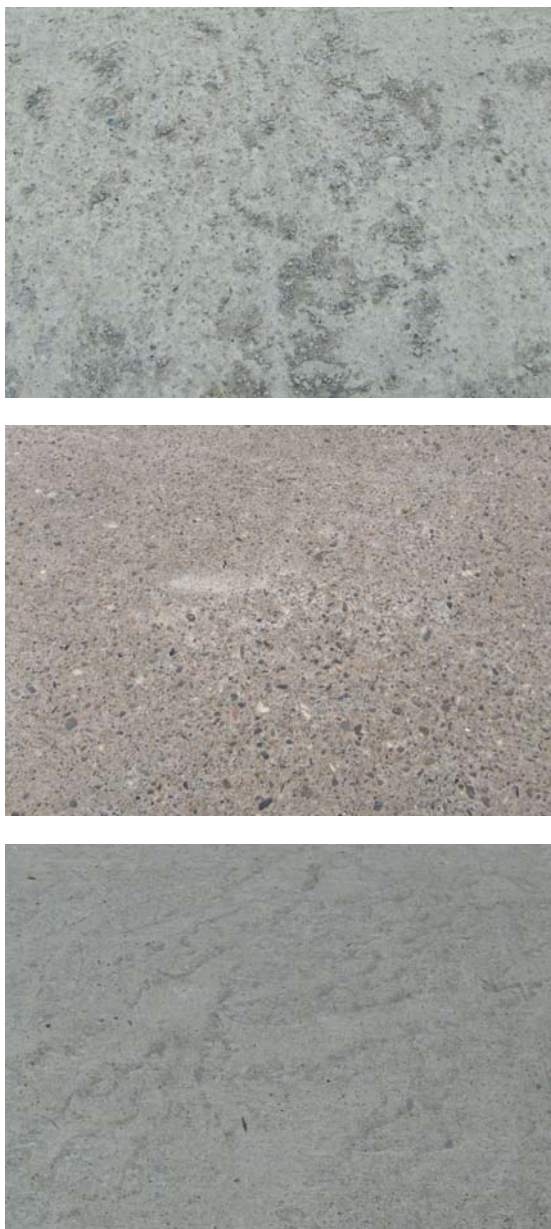
Other imperfections of concrete slabs-on-ground (Figure 10) are:

Figure 10. Imperfections on the surface of concrete

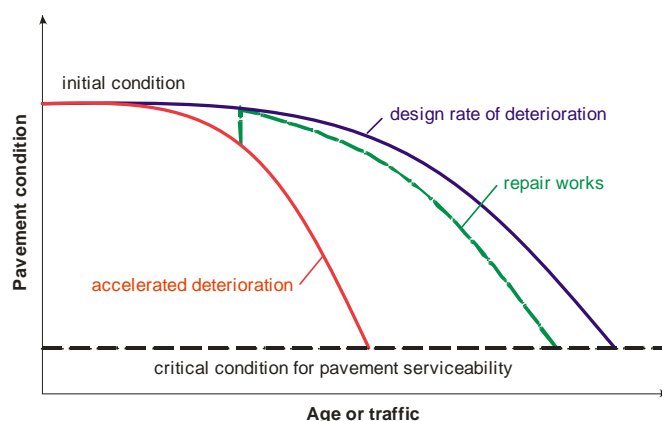
As shown in Figure 11, it is important to be mentioned that the pavement condition for industrial slabs-on-ground is a function of time and traffic.

Figure 11. Pavement condition as a function of time and traffic

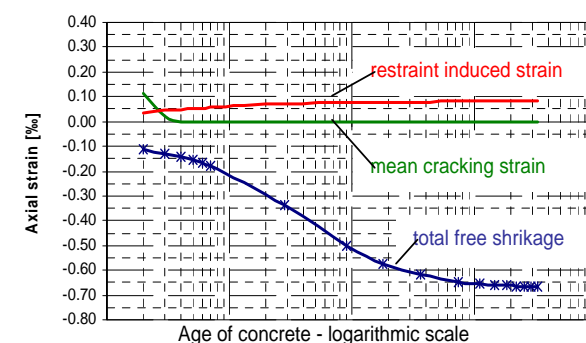
cement I 32.5 R, moderate weather

Figures 13 and 14 present the short and long term evolution of the shrinkage strain for a typical C16/20 mix, with 350 kg/m³ of cement, and various weather conditions at concrete placing. The evolution is shown both for Portland cement I 32.5 R and composite Portland cement II AS 32.5 R (with slag 6-20 %).

Figure 14. Long term variation of the shrinkage strain for the reference mix C 16/20 in the concrete pavement
