PARTICULARITIES OF STOŽE AND LOKAVEC LANDSLIDES - SPECIAL LABORATORY TESTS FOR LANDSLIDES MODELING

STANISLAV LENART
KARMEN FIFER BIZJAK

Slovenian National Building and Civil Engineering Institute
Dimičeva 12, Ljubljana
SLOVENIA

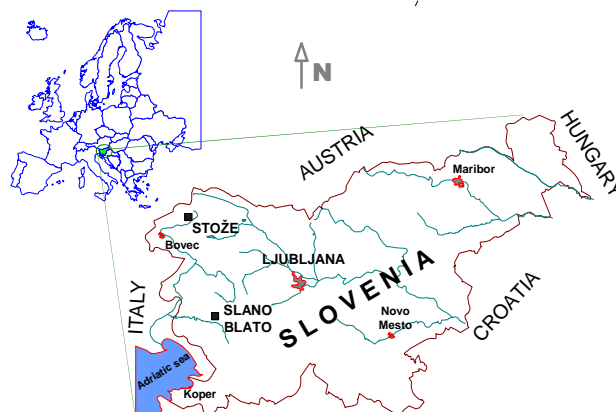
Fig.1. Locations of two landslides

In 1998, the strongest earthquake to have occurred over the last 100 years in the Upper Soča River Valley (ML 5.7) took place (Vidrih, 2001), with its epicentral area near Bovec (Fig.1). The Soča River valley is situated near the Slovenian-Italian border.

The Slano blato landslide is situated in the west of Slovenia (Fig. 1), above the village of Lokavec (Fig. 5), on the border between the Alps and the Mediterranean region. It has a relatively long history and was first documented in 1887.

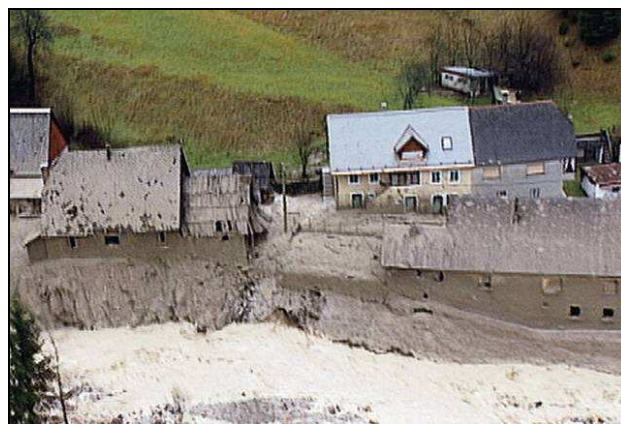
Fig. 2. Debris flow from Stože landslide when reached the village Log pod Mangartom

Just after the midnight on November 17, 2002, the deposited masses of the first debris flow started to flow towards the village of Log pod Mangartom (Fig. 2). More than 1 million m^3 of wet material traveled as a wet debris flow through a channel of the Predica torrent for 4 km and reached the village of Log pod Mangartom. (Oštir et al 2001) The velocity of the flow was estimated to be 8 to 15 m/s. Landslide moved downstream to the Koritnica river valley, stopping after 7 km from its origin. The debris flow in a few minutes killed seven people, destroyed 6 and severely damaged 23 residential or farm buildings.

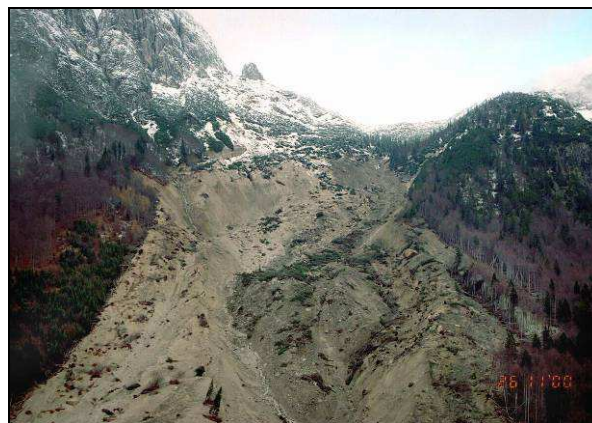
Fig. 3. The upper part of the Stože landslide

- The area of the second failure, the actual debris flow, was estimated to about 25 hectares of forest
- Its width was about 300 m, and it was 1.5 km long and up to 50 m thick
- Approximately 1,500,000 m³ of material has been moved (Fig.3)
- The ground level during the landslide has been lowered up to 40 m in some places, and has been risen up to 20 m in other
- Two bridges, several residential and industrial buildings were destroyed
- Seven people died
- There stayed about 3,000,000 m³ of unstable material in the landslide area, representing a potential danger of landslide recurrence

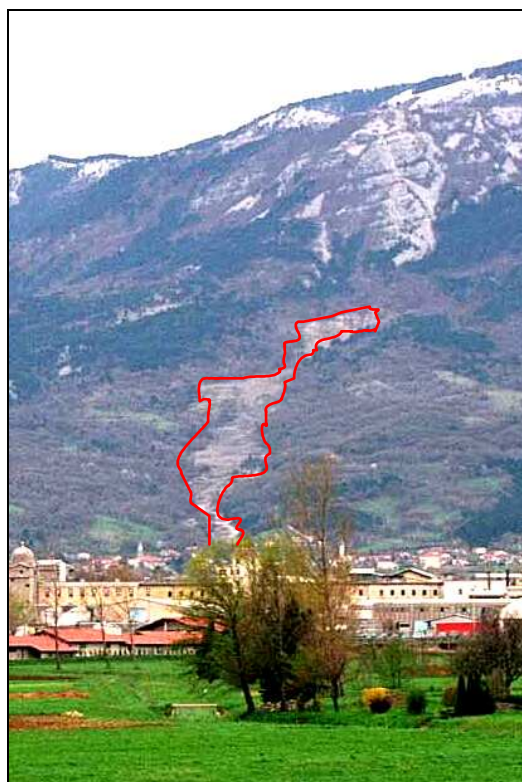
Fig. 5 The Slano blato landslide

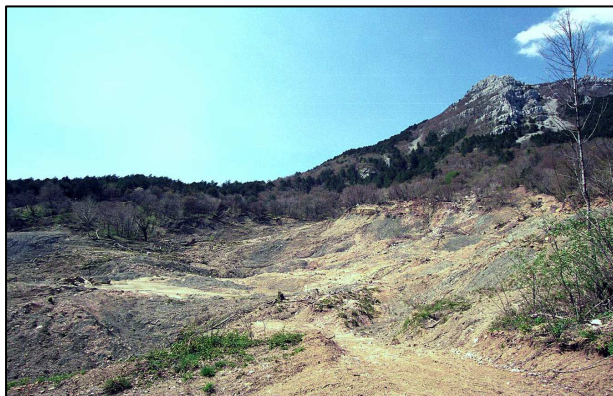
Fig.6 The upper part of the Slano blato landslide

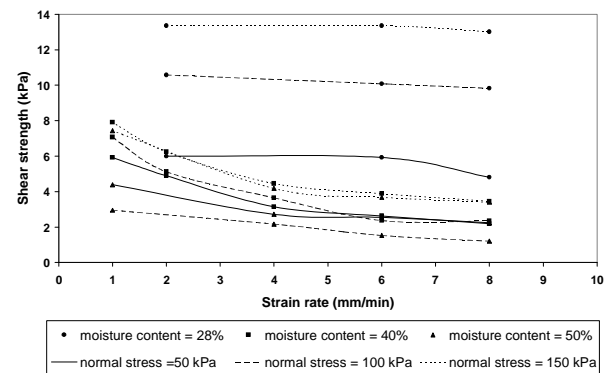
Fig. 11. Variation of residual shear strength of Slano blato landslide material with strain rate at different moisture content and normal stress (drained shear test)

As expected, in the case of Slano blato, the shear strength of tested material decreases as the moisture content increases. Probably due to the different moisture content, this effect is not so clear in the case of Stože landslide. It is evident that the shear strength increases with an increase in normal stress. Drained conditions during the test cause the increase of shear strength. This increase is especially significant in the case of Stože landslide and is smaller in the case of Slano blato landslide. Figures 10-15 compare drained and undrained conditions. Different behaviour of tested materials can be noticed from comparing the influence of rate of displacement upon shear strength. The shear strength decreases with an increase in rate of displacement in the case of Slano blato landslide (Fig. 10-11) and increases in the case of Stože (Fig. 12-13).

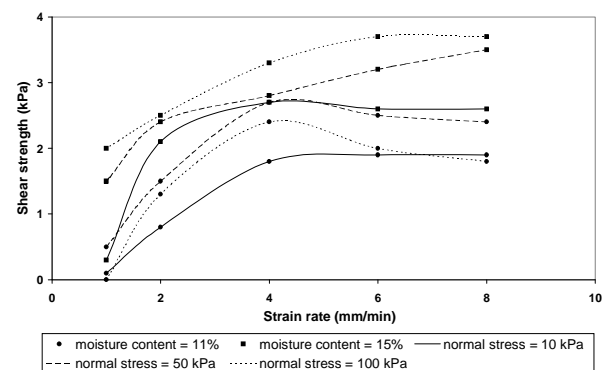
Fig. 12. Variation of residual shear strength of Stože landslide material with strain rate at different moisture content and normal stress (undrained shear test)

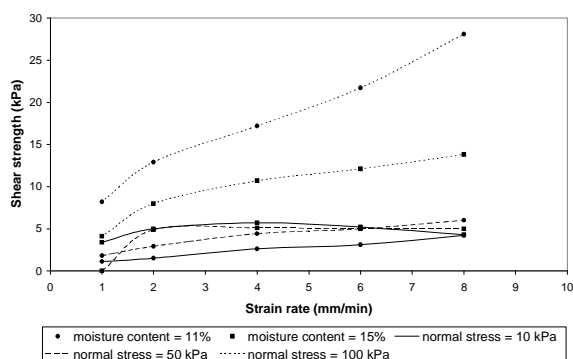
Fig. 13. Variation of residual shear strength of Stože landslide material with strain rate at different moisture content and normal stress (drained shear test)

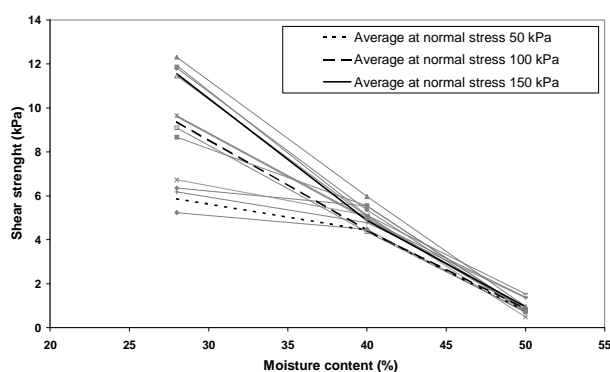
Fig. 15. Variation of residual shear strength of Slano blato landslide material with strain rate at different moisture content and normal stress (drained shear test)

Figure 15 presents the shear strength as a function of normal stress and moisture content. The shear strength still varies according to the normal stress, but at certain value of the moisture content the normal stress seems not to be important anymore.
