Metallographic and Numerical Methods Investigations about Failure of a Kaplan Turbine Runner Blade

Abstract: The paper presents the results of the failure analysis of a Kaplan turbine runner blade from a hydropower station in Romania. In order to determine the causes that led to the cracks, the authors first carried out metallographic investigations on a sample obtained from the cracked blade. The metallographic investigations included macroscopic and microscopic examinations (light microscopy and scanning electron microscopy) and X-ray diffraction analyzes (XRD). They led to the conclusion that the cracking of the blade was caused by fatigue, initiated by the numerous non metallic inclusions, which were discovered in the vicinity of the blade surface. The results obtained were confirmed by calculations on the resistance and service life estimations of the blade. The calculations carried out included the following steps: construction of the solid 3D-model of the blade, determination of the blade loads from hydrodynamic conditions, linear static analysis of the blade and service life estimations, calculated for maximal stress values of the concentrators. They led to the conclusion

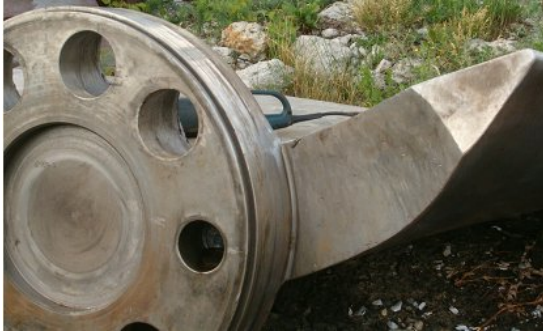
The analysis regarding the working conditions showed that the cracking occurred, Fig. 1, in one of the turbines from hydropower plants cascade, which operated at a higher head than the rest.

Fig.1 The cracked runner blade

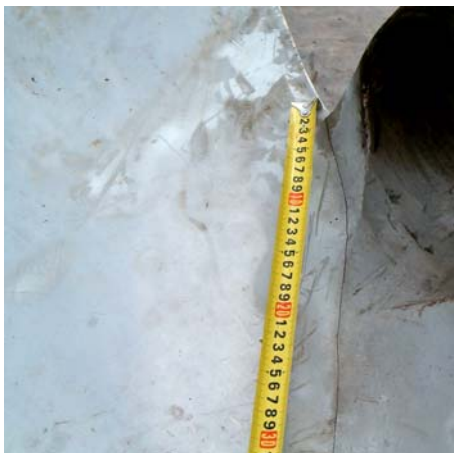
Fig.2 shows the path of the investigated crack, which penetrated the blade and developed to a final length of 600 mm, measured on the pressure side.

Fig.2 The crack on the pressure side

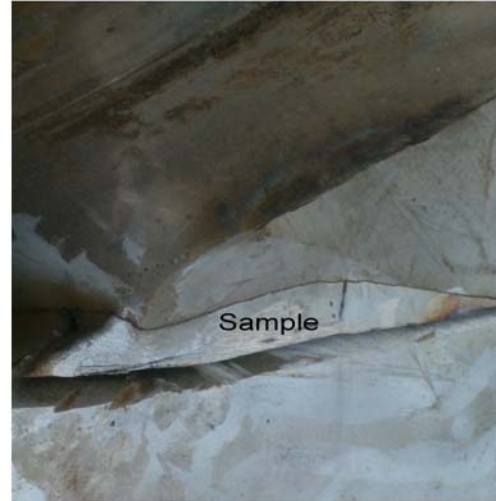
The sample for metallographic investigations was cut from the cracked blade as indicated in Fig.3.

Fig.3 Position of the metallographic sample

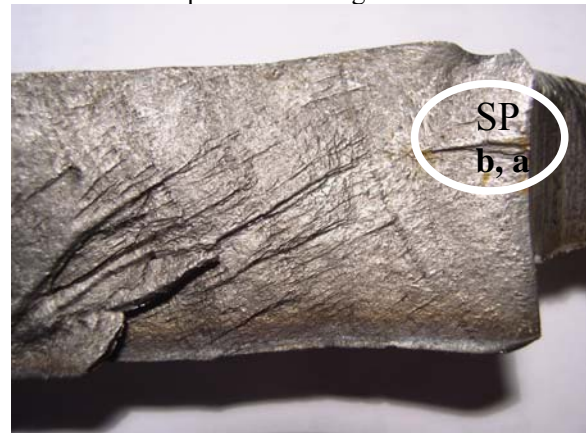
The macroscopic examination of the fracture surface (Fig. 4), revealed the specific appearance of fatigue cracking [1]. The surface is smoothened, resulting from the relative friction of the two pieces of the cracked blade one upon the other, during the alternative loads. The positions of the fan-shaped striations indicate that the cracking started from the region marked with "SP" (starting point) in Fig.4. The SEM-micrographs of the regions marked with "a" and "b" are presented in Fig.5.

Fig.4 Macrograph of the fracture surface

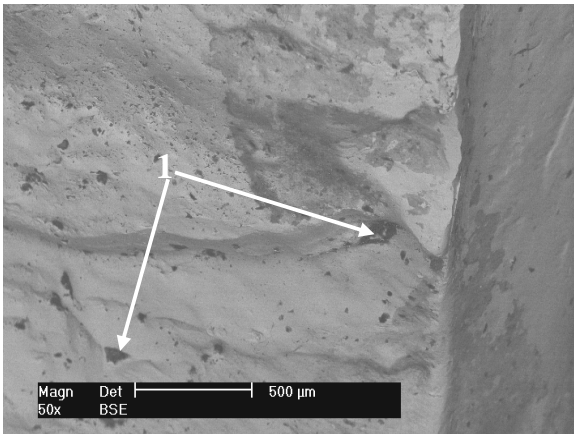
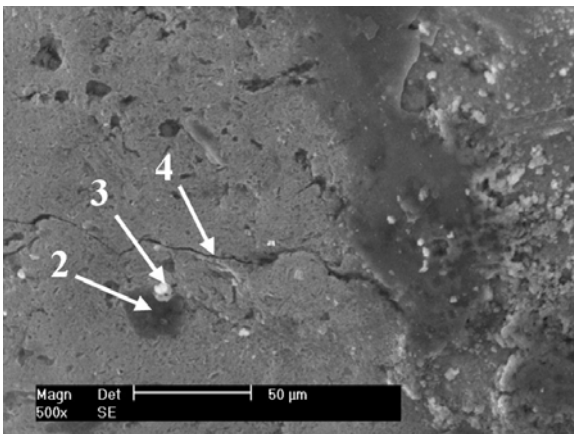
The images shown in Fig.5 indicate a high content of non-metallic inclusions in the blade material (marked with 1 in Fig.5.a). During the crack propagation, the operating water determined the corrosion of the base material surrounding these inclusions. As a consequence, the non-metallic inclusions released from the surface, leaving craters behind (position 2 in Fig.5.b), which were filled in with corrosion products (position 3 in Fig. 5.b).

a – BSE-image, 50x

b – SE-image, 500x

Fig.5 SEM-micrographs of the fracture surface

In the surface of the investigated sample numerous secondary cracks (as marked by 4 in Fig.5.b) were observed, which are specific for fatigue cracking [2], [3].

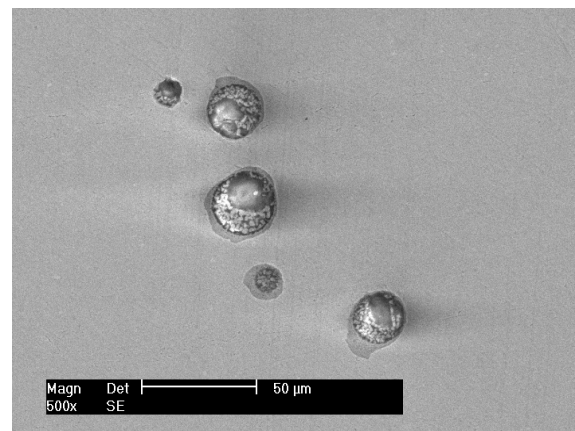
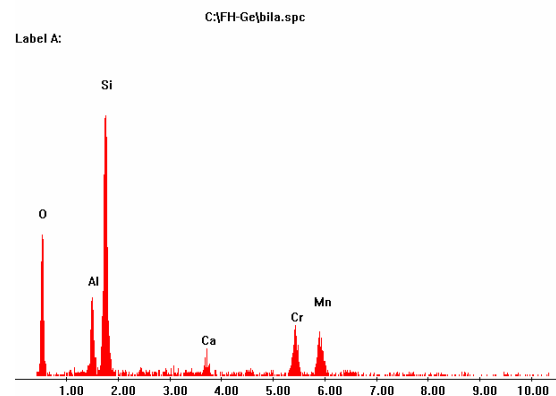
After SEM-examination, the crack surface was grinded, polished and examined with the scanning electron microscope (Philips XL30 ESEM). Globular non-metallic inclusions could be observed, as well as the surrounding corrosion attack of the metallic material, Fig.6.a. The XRD-analyze led to

the conclusion, that these inclusions are silicates and oxides, Fig.6.b.

a - SEM-micrograph

b - XRD-capture of the inclusions

Fig.6 Non-metallic inclusions in the vicinity of the crack surface

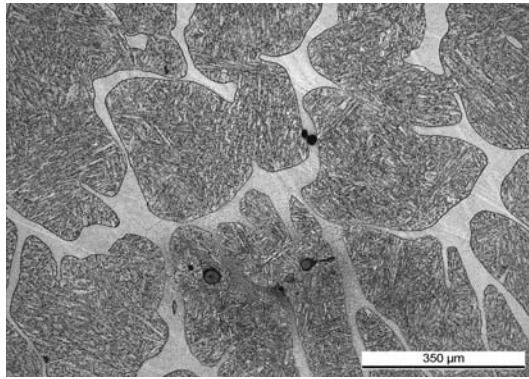
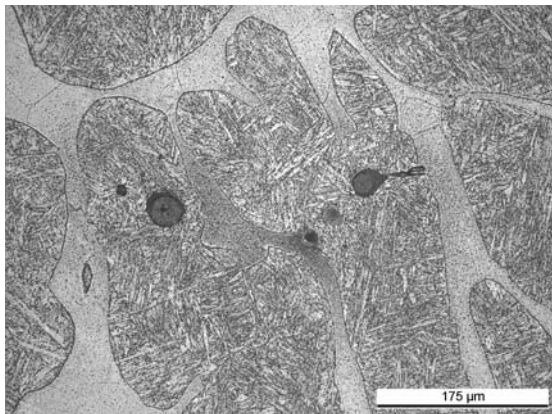
In order to visualize the structure of the blade material, the sample was etched using a V2A-solution and was examined with the light microscope (LEICA DM 6000M). As shown in Fig.7, the microstructure is consisting of martensite, containing a high percentage of ferrite, with grid-like distribution. The presence of numerous non-metallic inclusions is attested also by these images.

The metallographic investigations led to the conclusion that the cracking of the blade was caused by fatigue and was initiated by non metallic inclusions existing in the vicinity of the blade surface. The crack propagation occurred gradually, through development of the principal fracture front. Because of the high content of non-metallic inclusions and the inhomogeneous structure of the blade material, additionally numerous secondary cracks developed inside the material.

Fig.7 Structure of the blade material

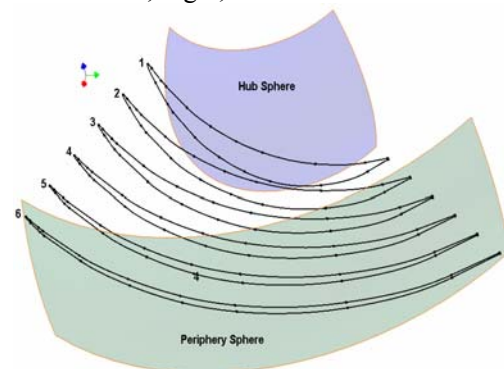
- starting with the plane coordinates of the profiles, the 3D coordinates disposed on cylinders to the radius specified in execution drawings of the runner were calculated, Fig.8;

**Fig.8** Blade profiles disposed on cylinders

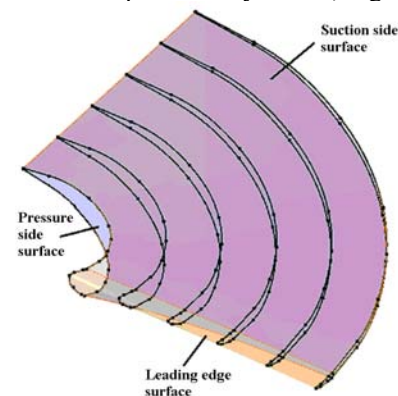
- generation of the suction side surface, pressure side surface and leading edge surface, based on closed loops of the 3D coordinates disposed on cylinders, Fig.9;

**Fig.9** Suction side surface, pressure side surface and leading edge surface of the blade

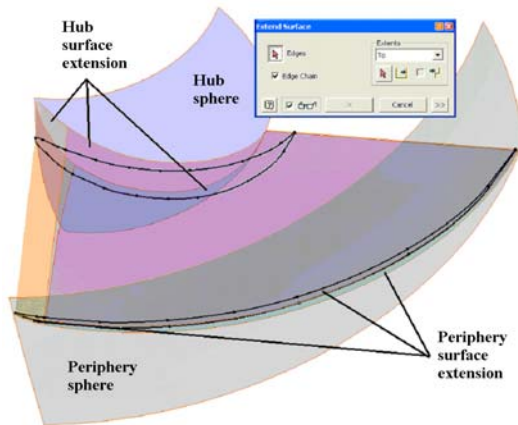
- extensions of blade's surfaces: the previous surfaces must be extended to the hub and periphery direction to obtain the surfaces of the complete blade, Fig.10;

Fig.10 Extensions of blade's surfaces

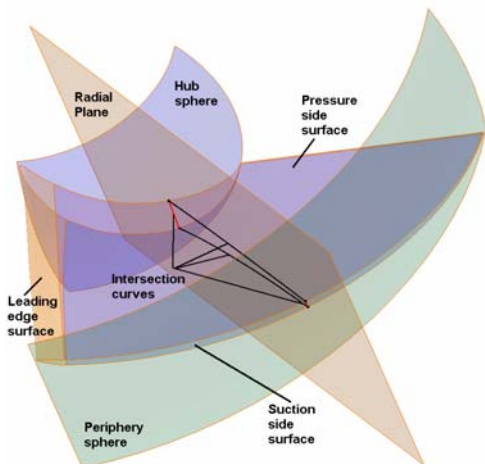
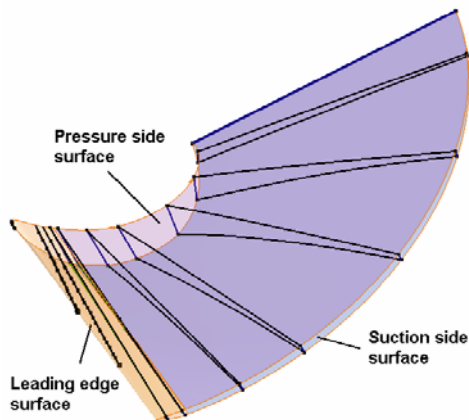
- intersections of the blade surfaces with radial planes, disposed at imposed angles, Fig.11, which will generate a number of closed loops disposed on radial planes, Fig.12;

Fig.11 Intersection curves for a radial plane

Fig.12 Intersection curves for multiple radial planes

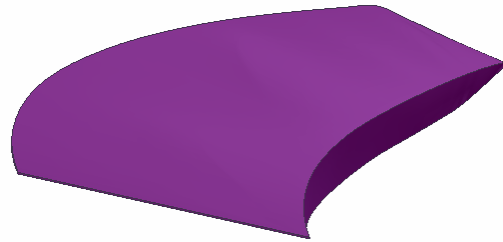
- generation of the solid model of the blade, based on the previous closed loops, Fig.13;

Fig.13 Solid model of the blade

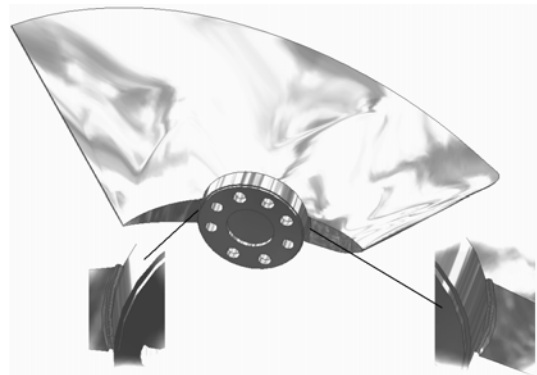
- completion of the 3D solid geometry of the blade with the flange and stress relieve groove with different geometry, Fig.14 and Fig.15.

Fig.14 The solid model of the blade with stress relieve groove R8x20

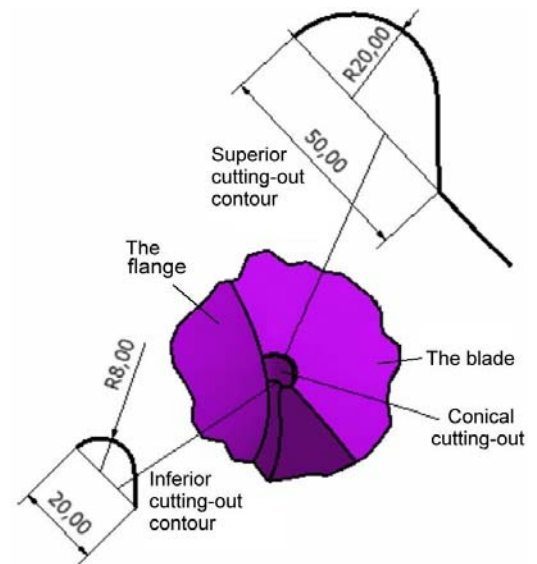
Fig.15 The geometry of the stress relieve groove R20x50

To reduce the maximal stress values, the geometry of the stress relieve groove was modified from R8x20 to R20x50, Fig.15. The results are numerically shown in Table 4.

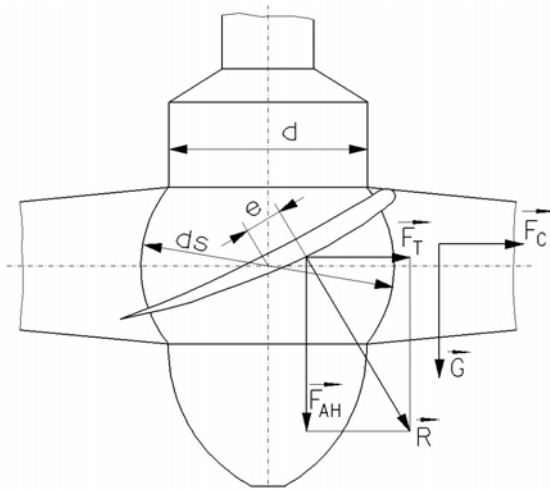
The hydrodynamic loads applied on the axial runner are presented in Fig.16:

- the gravity load \vec{G} ; from Inventor software results the blade mass ~ 4000 kg;
- the centrifugal force \vec{F}_C generated for the runner speed 115.4 rot/min;
- the axial thrust \vec{F}_{AH} , resulted from the measurements on model;
- the tangential force \vec{F}_T , which contribute to the machine couple;
- \vec{R} is the resultant of the hydraulic force on the blade;
- “e” is the distance between blade axis and the resultant direction \vec{R} .

Fig.16 The hydrodynamic loads applied to the runner

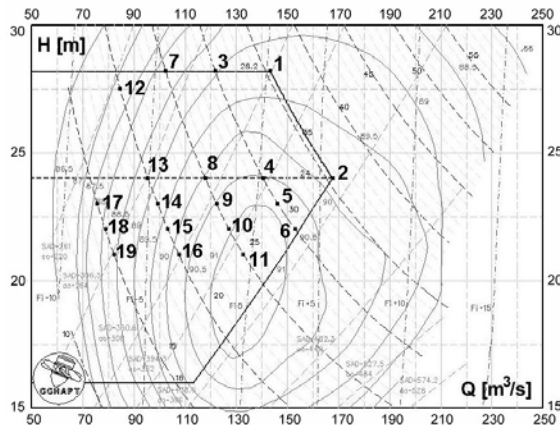
The placement of the operating points cover the area of the turbine operation and are shown in the prototype hill chart H-Q from Fig.17.

Fig.17 The placement of the operating points in the prototype hill chart

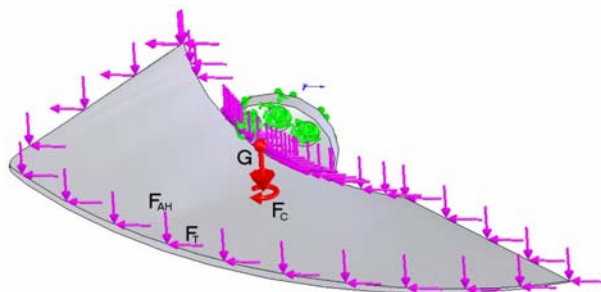
Fig.18 shows the loads and restrictions applied to the blade:

- fixed type constraints applied to the flange holes, which impose 0 value for the translations and rotations of the selected entities;
- axial thrust F_{AH} ;
- tangential force F_T ;
- centrifugal force F_C ;
- blade gravity G .

Fig.18 Loads and restrictions applied to the blade in the finite element software

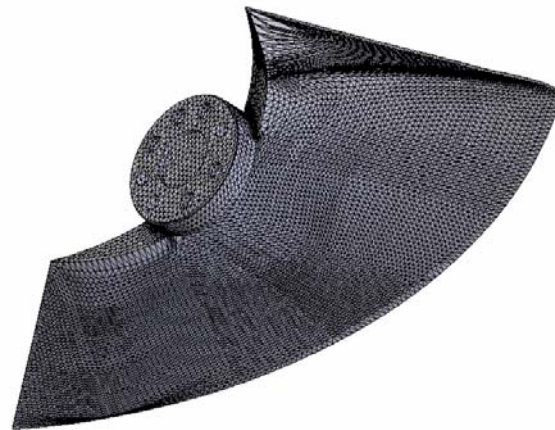
The mesh is shown in Fig. 19. For original stress relieve groove R8x20 a local fine mesh was used, Fig. 12. The results are presented numerically in Table 3, and graphically in Fig. 21 and Fig. 22, only for operating point no. 1.

Fig.19 The blade mesh

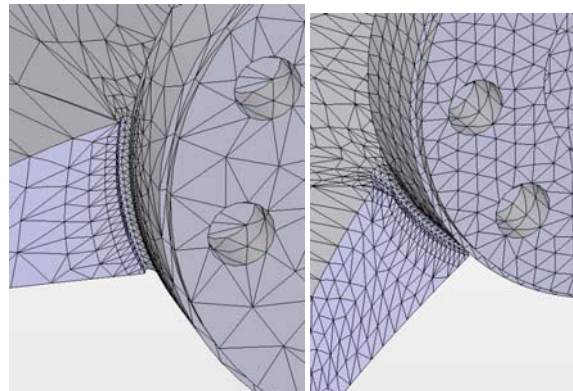
Fig.20 The blade mesh in the stress relieve groove area

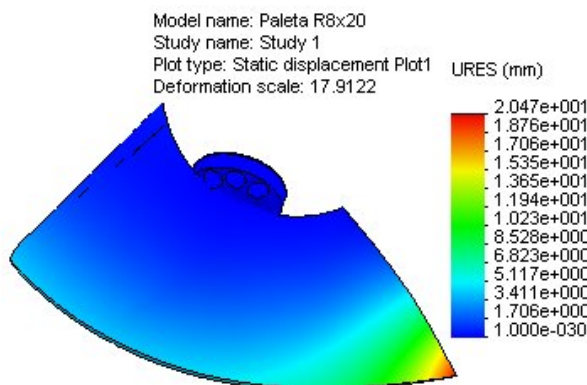
**Fig.21** The resultant displacement plot - Point 1
stress relieve groove R8x50 (4 blades)

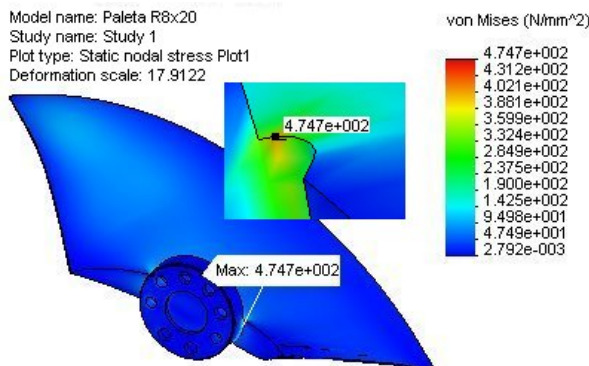
**Fig.22** The Von Mises stress plot - Point 1
stress relieve groove R8x50 (4 blades)

The metallographic investigations and the calculations carried out led to the conclusion that the cracking of the blade started and developed from the stress concentrator placed between blade and blade flange on the leading edge direction.

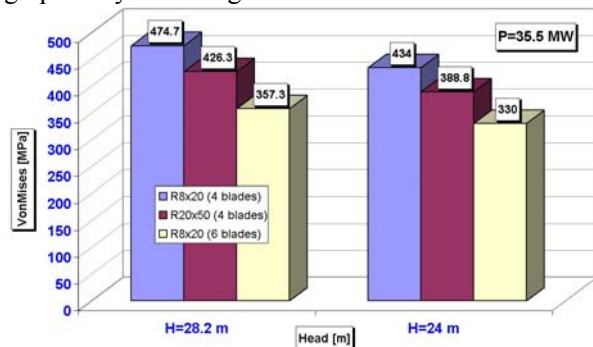
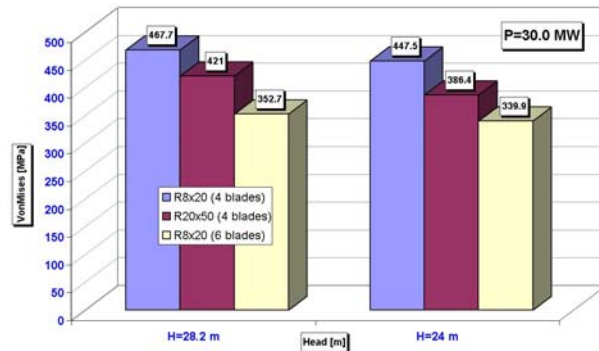
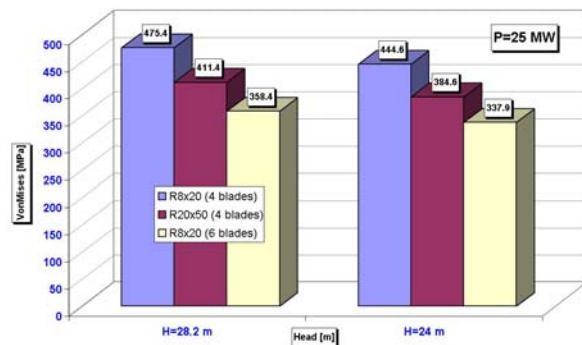
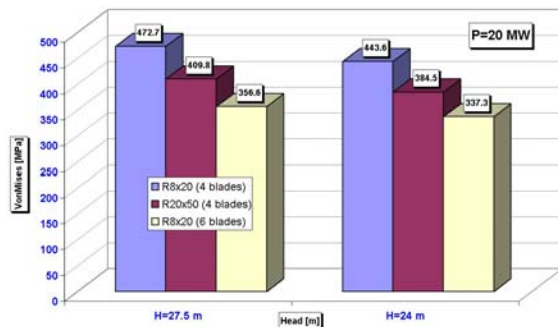
The Von Mises values are presented graphically in the Fig. 23, Fig. 24, Fig. 25 and Fig 26 for the power steps P=35.5 MW, P=30 MW, P=25 MW and P=20 MW. The displacement values are presented graphically in the Fig. 27.

**Fig.23** The comparison between Von Mises
values for power step P=35.5 MW

Fig.24 The comparison between Von Mises values for power step P=30.0 MW

Fig.25 The comparison between Von Mises values for power step P=25.0 MW

Fig.26 The comparison between Von Mises values for power step P=20.0 MW

From all previous figures, the decreasing of the VonMises values from the initial geometry solution of the stress relieve groove R8x20 (4 blades), to the solutions R20x50 (4 blades) and R20x50 (6 blades) is obvious. The same conclusion is obtained for displacement, from the geometry solution of the stress relieve groove R8x20 (4 blades) or R20x50 (4 blades) to R20x50 (6 blades) solution.

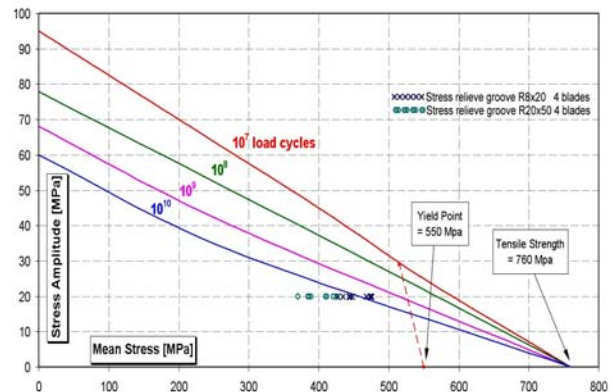
The yield strength value of the blade material is $R_{p0.2 \min} = 550$ MPa. The calculated values of the stress for stress relieve groove R8x20 and R20x50 and 4 blades were introduced in Haigh diagram, Fig. 28 [4].

From the Haigh diagram results that, for stress relieve groove R8x20, the blade cracks should be obtained between $10^9 \div 10^{10}$ of the fatigue cycles. To reduce the stress concentrator values, a number of different stress relieve groove geometry were studied. The optimal solution was obtained for stress relieve groove R20x50, where the stress values were reduced in the range between 45...60 MPa (see Table 4 and Fig. 28), but not enough to promote as a final solution.

Fig.28 The Haigh diagram

The results from Fig.27 are ideally, because the fatigue curves are obtained in laboratory for samples with controlled chemical composition and homogeneity, with no fissures and surfaces or deeply defects. For these reasons, in service life estimations and fatigue calculus is recommended that the stress concentrator values will not be higher than half of yield strength value of the material, in our case 275 MPa.
