# Comparison of FEA and Experimental Results for a Steel Frame Connection

*Abstract:* The paper presents the results and the similarity between the experimental test and FEA of a steel frame connection. The same connection is analyzed in two situations. The second case analyses the connection having some of the elements strengthened in order to increase the capacity of the specimen. The analysis is performed using solid finite element and is compared to the experimental test performed in the laboratory. Several considerations, such as identical conditions for force definition, have to be taken into account in order to obtain good results.

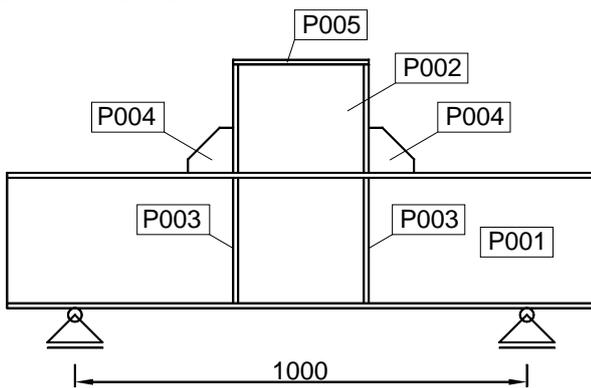
First, it was tested a welded beam to column connection as shown in Fig.1. The force was applied normal to the column. The strain gauges gave the results for each step of 100kN. The final value of force P was 2000kN in order to avoid yielding in the assembly. This was necessary because the second test would have been performed on the same sample and the plastic deformations would have given inaccurate results.

Fig.1 Initial experimental connection

Part	Cross-section	Length [mm]	Material
-0-	-1-	-2-	-3-
P001	HEB300	1300	OL52 (S355)
P002	HEB300	150	OL52 (S355)
P003	Pb140x10	240	OL52 (S355)
P004	Pb100x10	100	OL52 (S355)
P005	Pb300x25	300	OL52 (S355)
P006	Pb240x10	1300	OL52 (S355)
P007	Pb240x10	460	OL52 (S355)

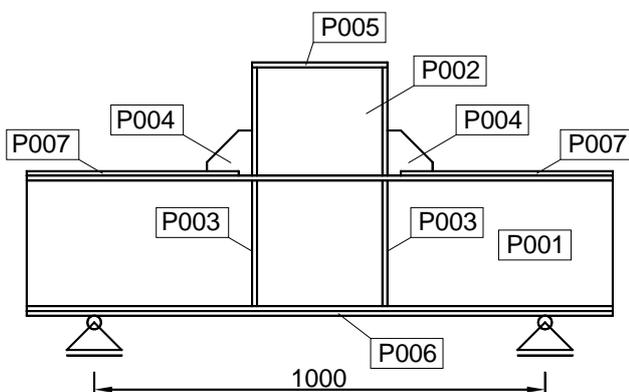
Fig.2 Strengthened experimental model

The strengthened experimental model is presented in Fig.2. The difference between the two models is the plates welded on the exterior of each flange denoted P006 and P007, in Table 1.

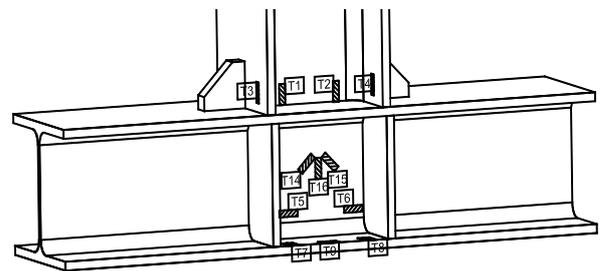
The strain gauges were put on the model as follows: two on the beam's web, two on each of the beam's flange, two on the column's web for the strains developed normal to the force's direction, two on the column's web for the principal directions and one for strain in the direction of the force and there are three more strain gauges placed on one of the columns flange for the strain normal to the force's direction. A sketch of the gauges placement is shown in Fig.3.

Fig.3 Gauges position

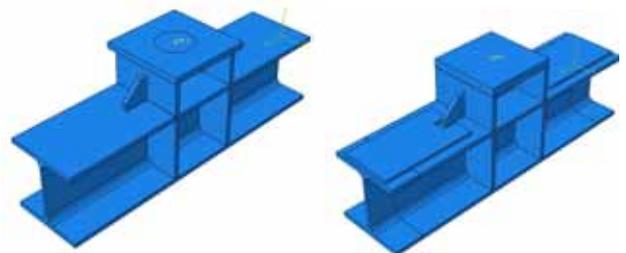
For the simulated analysis, the models were created as solids like in Fig.4.

Fig.4 Modeled connection

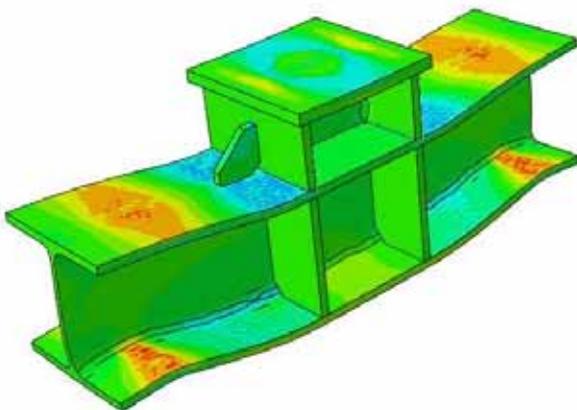
Fig.5 Deformed shape for initial connection

In Fig.5, the deformed shape of the first model (un-strengthened) also shows the stresses in longitudinal direction of the column. Red represents the tension and blue means compression.

From the two figures it can be seen that the models have the same behavior but the areas where

the stress was maximum, are now smaller or gone, meaning that the connection can still be loaded until it reaches the yielding point. Another thing that can result from the analysis is the fact that, although the strengthening parts on the upper flange of the column are not continuous, there is no stress concentration in the nearby of the welding between the column and the beam.

In the first situation, the location where the stresses have high values, are represented by small areas. These locations are: the supports of the model, the corresponding zones but on the other flange, the vicinity of stiffeners.

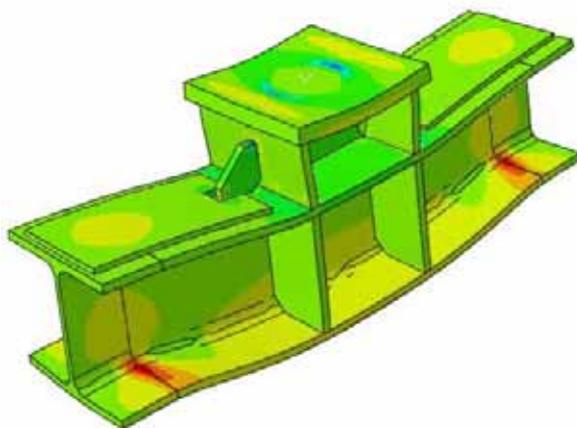
Fig.6 shows the same stress at the same force applied on the plate. Also the color representation is the same as mentioned before.

Fig.6 Deformed shape for the strengthened elements

In the second case, the areas, with close values for the stress, are larger meaning that the distribution of stress is more uniform and the location of yielding stress can be seen only in the support surfaces. The circular surface has also yielding points because the bending of the column had an influence on the bending of the plate welded to the beam. The same print could be seen on the experimental specimen, where the force was distributed finally through two areas apart from each other due to the detachment of the center of the plate from the pressure cylinder.

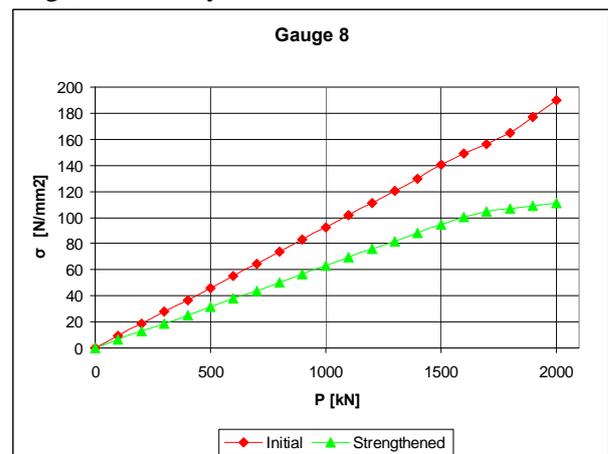
Fig.7 Results for gauge 8

Mainly, the stresses in the strengthened elements are less than for the first case, as it can be seen in the charts in Fig.7 and Fig.8. The rhombic filled line represents the values for the un-strengthened model and the triangle filled line represents the model with consolidation plates.

Fig.7 and Fig.8 show the stress of gauges 8 and 9 which are positioned on the lower flange of the column. Here, the stresses are reduced by 25-40%.

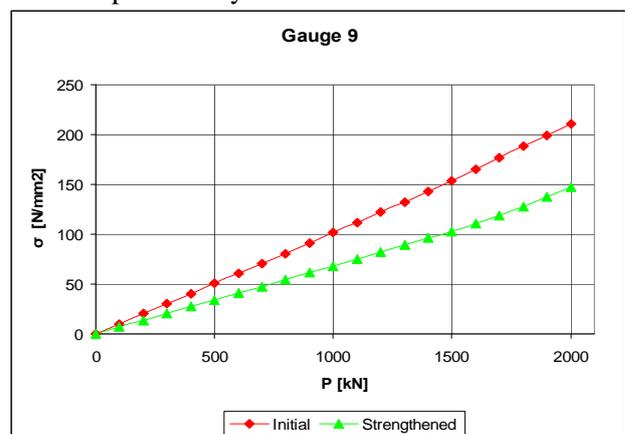
Fig.8 Results for gauge 9

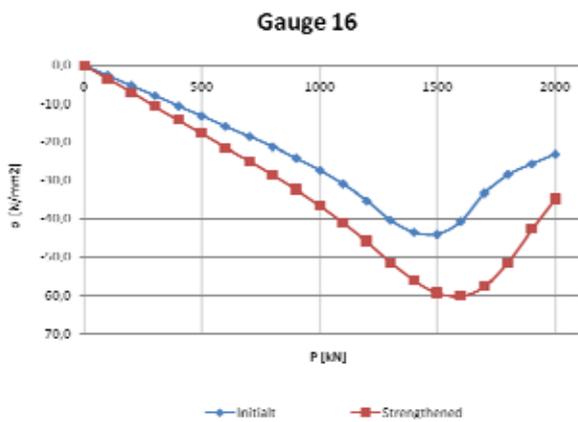
Fig.9 Results for gauge 16

Fig.9 shows the values obtained in the location of gauge 16, placed on the web of the column. It can be seen that the stresses in the case of un-strengthened model are less than the values obtained in the second case. It results that the web of the column is more stressed, but the values are not very high.

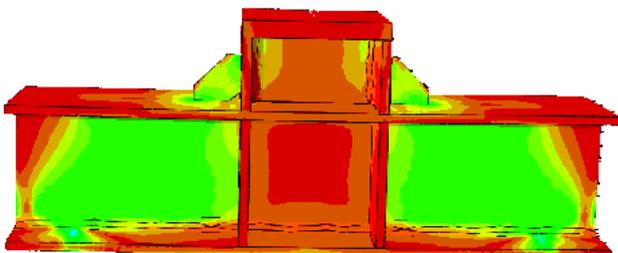
Fig. 10 presents the stresses on the vertical direction for the un-strengthened model.

Fig.10 Stresses Syy for initial connection

For the un-strengthened model it can be seen that the stresses, which reach high values, cover a larger area (green), in the web of the column, than for the second case.

The panel between the vertical stiffeners of the column shows a larger area for the higher stresses, in the first, un-strengthened model than the second model.

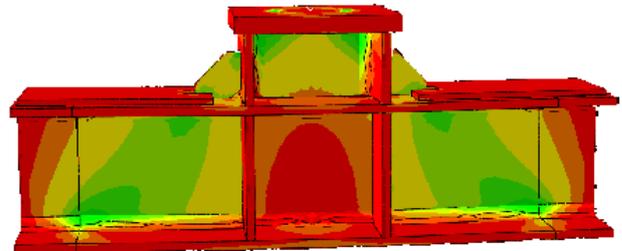
Fig. 11 presents the stresses on the vertical direction for the strengthened model.

Fig.11 Stresses Syy for strengthened connection

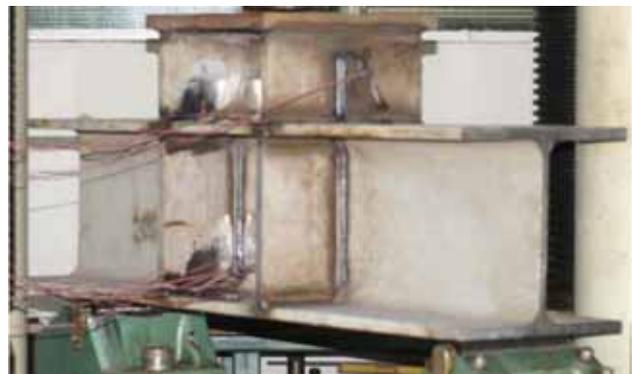
For the experimental test of the joint, it was used a universal testing device with maximum load of 3MN, type ZD300. This is equipped with a bending device with roller supports which allow the positioning of the load at middle span as shown in Fig. 12.

Fig.12 Experimental stand

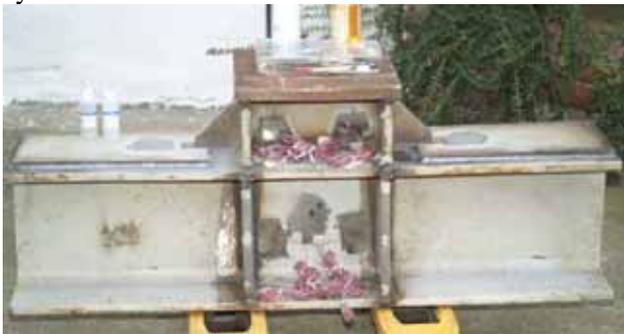
The lateral view for the experimental specimen is presented in Fig. 13 as well as the positioning of the strain gauges and the imprint of the pressure cylinder.

Fig.13 Experimental specimen

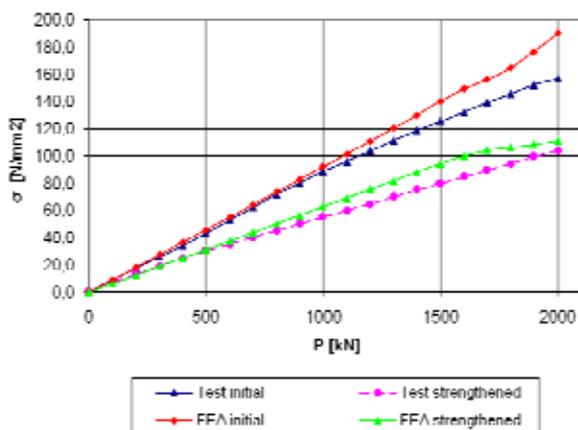
Gauge 8

Gauge number 8 is positioned at the lower flange of the column so the maximum stress has the direction of the column. In Fig.14 there should be compared the red line (rhombic filled) with the blue line (triangle filled). These two present the results obtained for the first test. Red line is obtained from finite element analysis while the blue line is obtained from experimental test. It can be observed that the values are very close and they follow the same pattern.

The other two lines represent the results for the strengthened experiment. The green line (triangle filled) is obtained from finite element analysis and the magenta (circle filled) is obtained from the experimental results. As in the case of un-strengthened test the two lines follow the same pattern and have close values.

Fig.14 Results for gauge 8

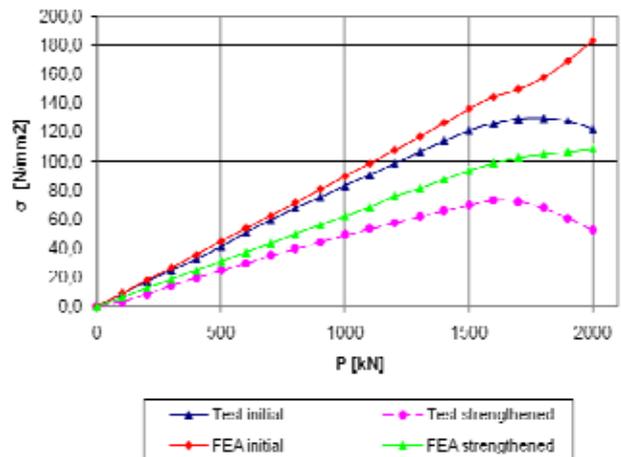
The lines in Fig.15 and Fig. 16 have the same legend and it can be seen that the same conclusions can be drawn as presented for gauge number 8.

Gauge 7 and 9 are positioned also at the lower part of the column's bottom flange, under each stiffener.

Fig.15 Results for gauge 7

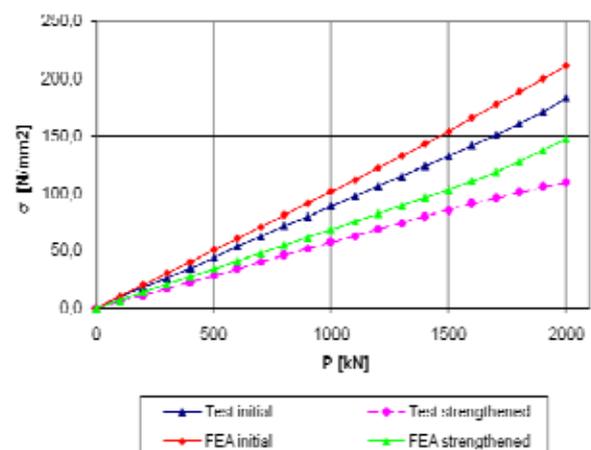
Gauge 9

Fig.16 Results for gauge 9

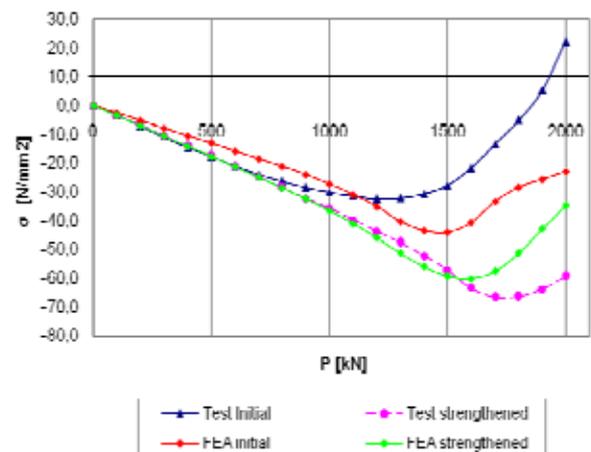
Gauge 16

Fig.17 Results for gauge 16

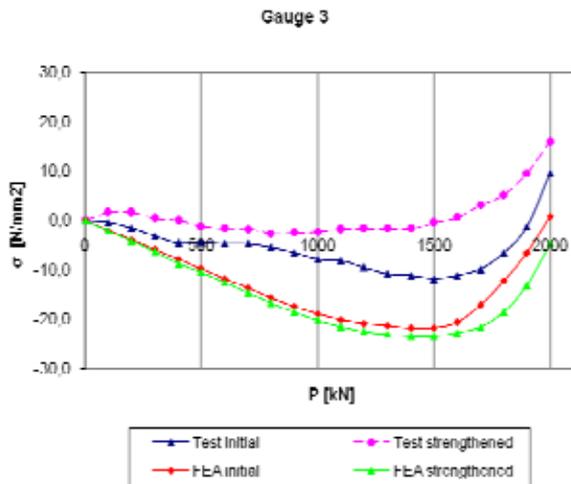
Gauge 3 is positioned on the left flange of the column, inside the cross-section.

Fig.18 Results for gauge 3

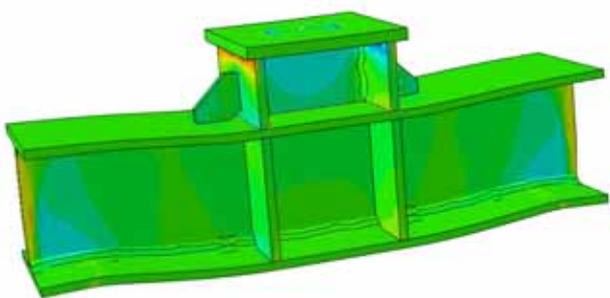
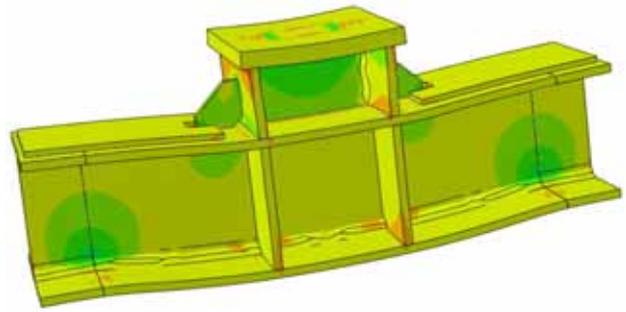
Fig.20 Stress Syy (initial)

Fig.21 Stress Syy (strengthened)

Fig.20 has to be compared to Fig. 21 in order to see how stresses developed in these two situation. A better understanding may be described in Fig. 22 and Fig 23 where the ratio between stresses on the pressure surface, support surfaces and stresses in the elements is higher in the strengthened specimen.

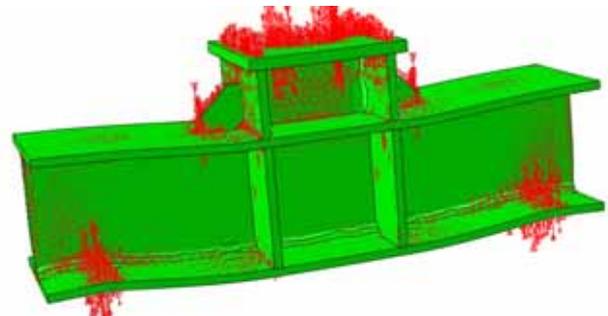
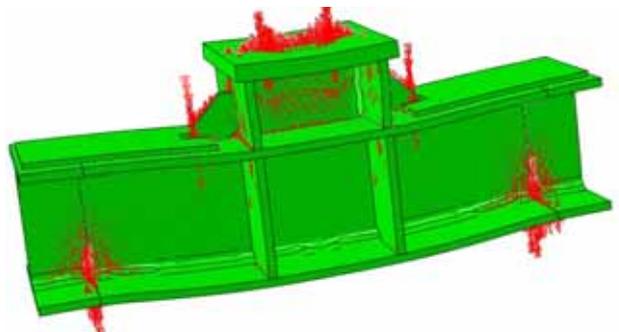
Fig.22 Stress Syy (initial)

Fig.23 Stress Syy (strengthened)

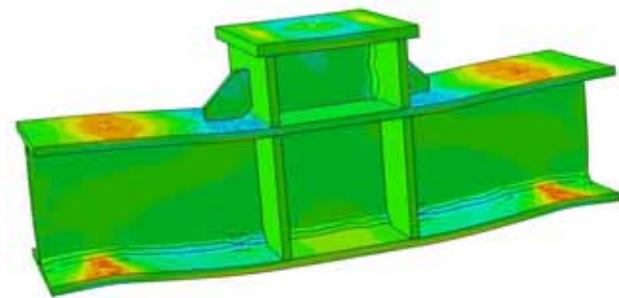
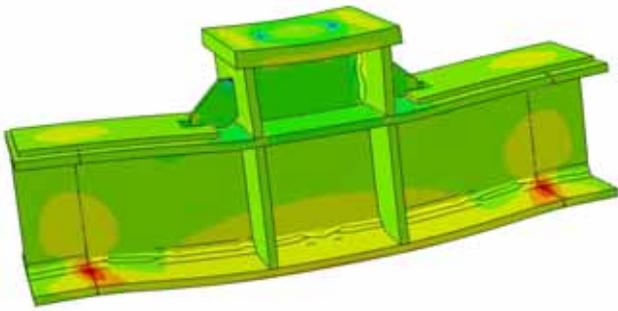
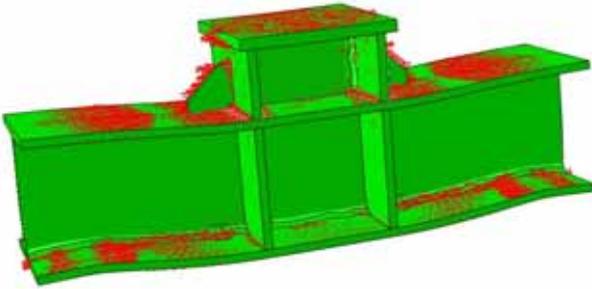
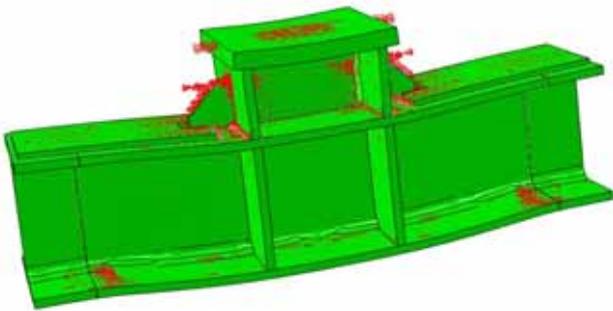
Fig. 24 has to be compared to Fig. 25 and Fig. 26 to Fig. 27 where the same difference in stress ratio is presented.

Fig.24 Stress Sxx (initial)

Fig.25 Stress Sxx (strengthened)

Fig.26 Stress Sxx (initial)

Fig.27 Stress Sxx (strengthened)

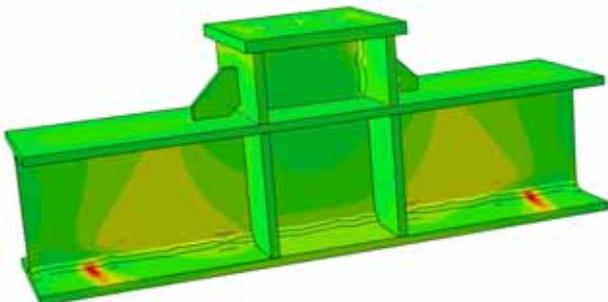
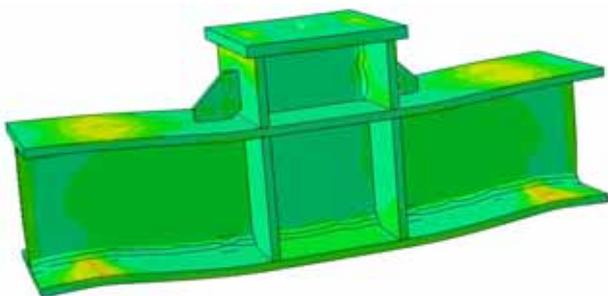
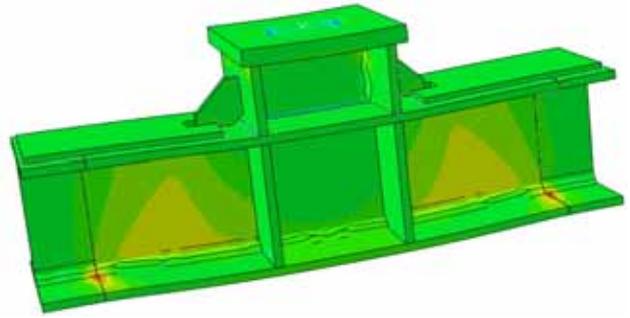
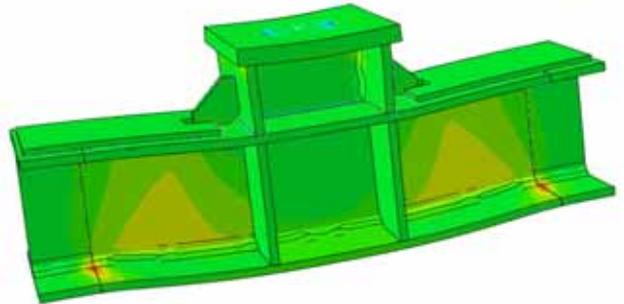
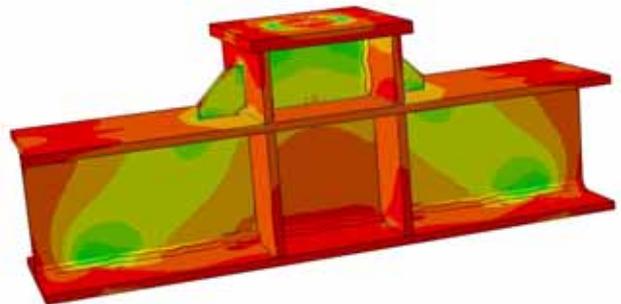
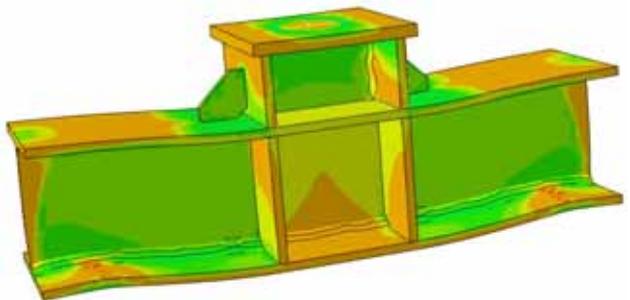
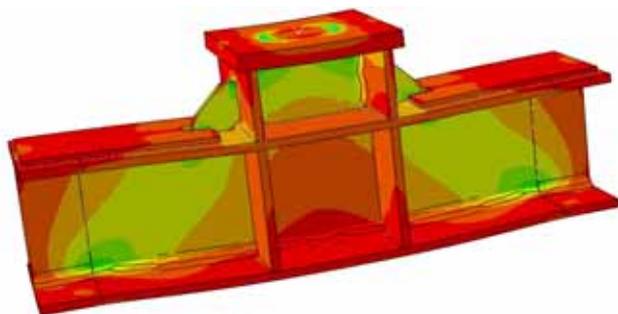
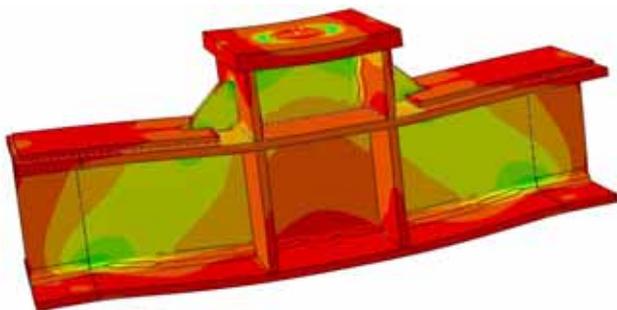
It can be noticed, in Fig. 28, to Fig.35 that the strengthened specimen does not differ very much from 1000kN to 2000kN. (the figures look almost the same because the distribution is the same but the values are proportional to the applied load).  
 The panel between the stiffeners of the column does not have an obvious shear behavior and the values of the stresses in principal direction have, almost, the same values as for the vertical direction

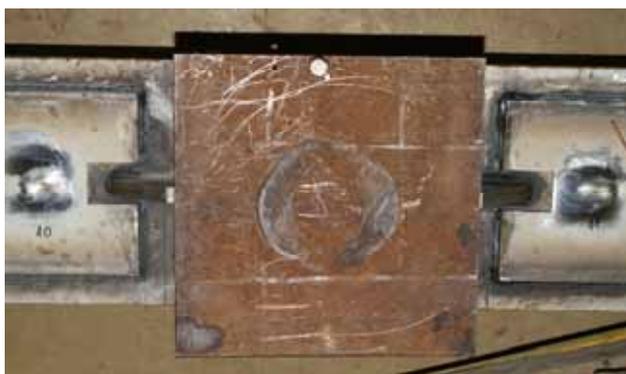
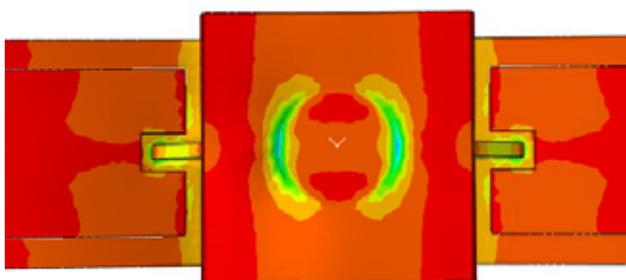
Fig.36 Print of pressure cylinder (test)

Fig.37 Print of pressure cylinder (FEA)

The last two figures, Fig. 36 and Fig. 37 present the imprint of the pressure cylinder in the experimental test and in the finite element analysis. Although both cases started with a circle as pressure surface, because of bending and deformation there has appeared two surfaces which relate very closely to the real situations. This was possible by defining a contact definition between a cylinder and the
