Investigation of leakage current flow through wooden poles structures on overhead distribution system

Abstract: - Insulation degradation leading to leakage current flow through the high voltage insulator is a major problem faced by various power distribution utilities. The excessive leakage current flow into the wooden supporting structures (wooden cross-arm and pole) leads to pole-top fires and subsequently power cut-off. Most prior researchers focused on flashover phenomena of insulators rather than investigation of leakage current leading to pole fire. This paper investigates the continuous current flow path originating from the high voltage conductor to various locations through the wooden pole. The results are of significance to the study of high voltage insulation whereby it extended the study of leakage current into the wooden supporting structures. Experiments were conducted on various locations of wooden pole to detect and track the leakage current flow. Also the moisture contents at these locations were measured to investigate its effect on the leakage current through the wooden pole structure.

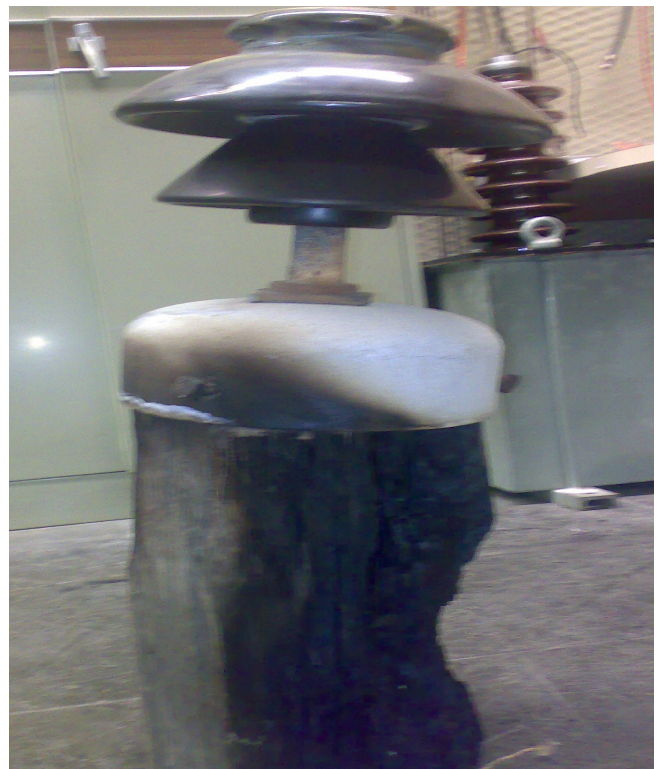
Fig.1 Pole Top Fire Sample

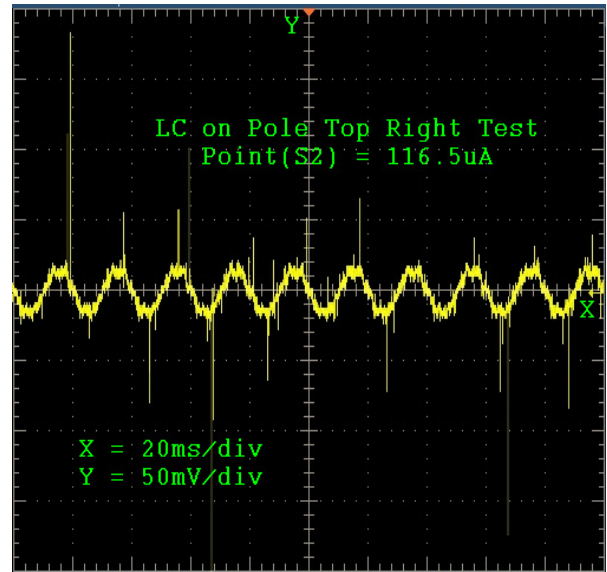
Fig.7 Leakage current waveform at pole top right test point

The second step was to measure the leakage current through the top right portion of wooden pole and was done by inserting a metallic rod into the top right hole of the wooden pole and its corresponding switch S2 was closed while all remaining switches were kept open. A leakage current of 116 μ A was measured and its waveform is shown in Fig.7.

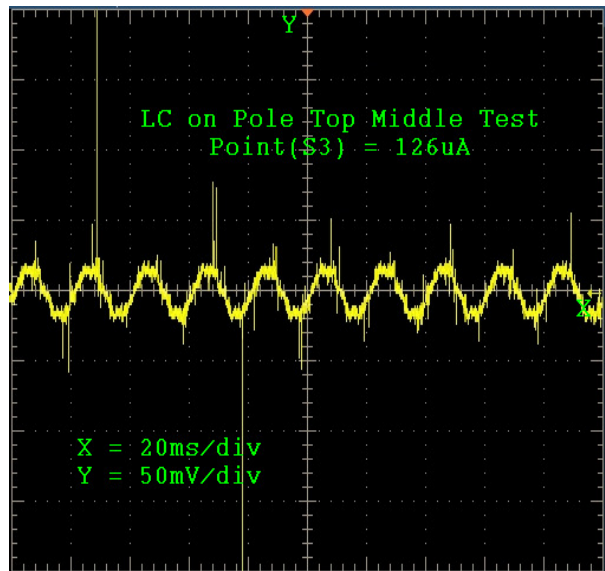
Fig.8 Leakage current waveform at pole top middle test point

A high leakage current of 126 μ A was measured at the top middle test point of wooden structure as shown below in Fig.8. The moisture content of 7.025% was measured at this test point. .

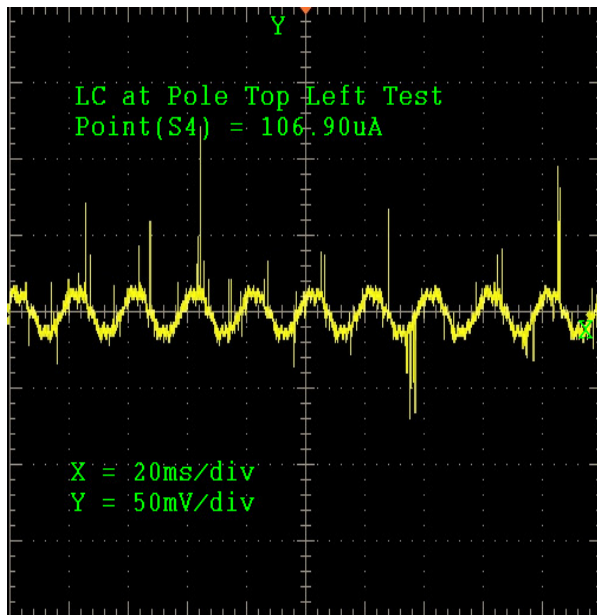
Fig. 9 Leakage current waveform at pole top left test point

A leakage current magnitude of 106.9 μ A was measured at the top left test point of wooden structure as shown below in Fig.9. The moisture

content of 6.625% was recorded at this test point location.

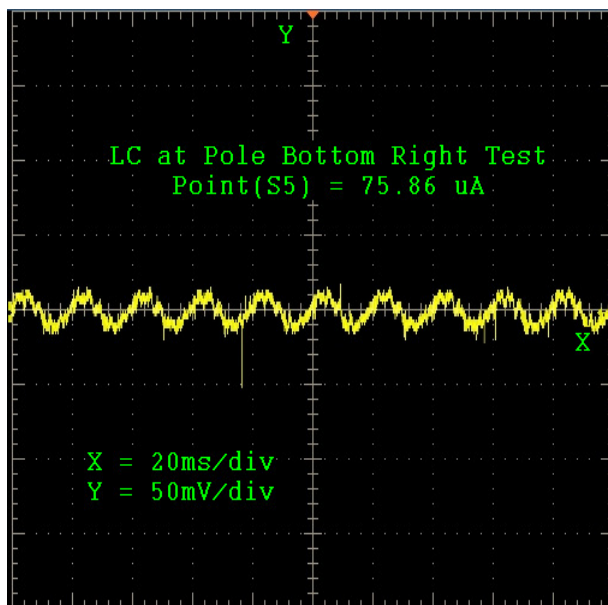
Fig.10 Leakage current waveform at pole bottom right test point

The second step was again repeated to measure the leakage current at bottom right test point on the wooden pole structure (S5 was closed and remaining switches were kept open). A magnitude of 75.86 μ A was recorded and its waveform is shown below in Fig.10. A moisture content of 7.67% was also measured and is shown in table 1.

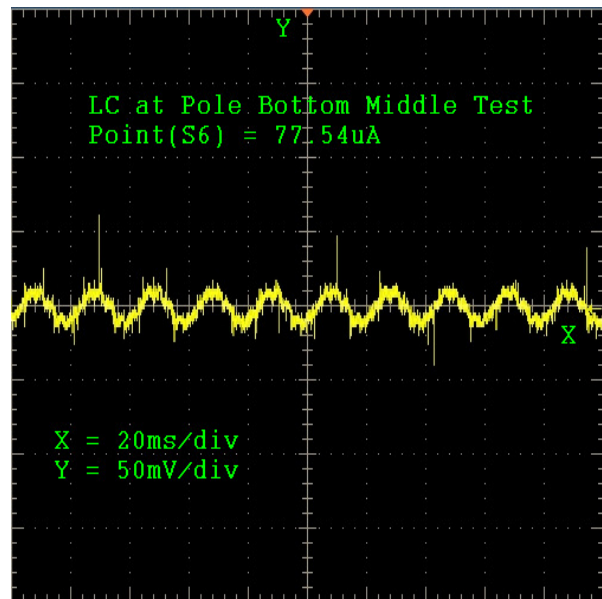
Fig.11 Leakage current waveform at pole bottom middle test point

Similarly, by closing the S6 and keeping remaining switches open, a leakage current magnitude of

77.54 μ A was measured at bottom middle test point on wooden pole structure as shown below in below Fig.11 and a corresponding 7.75% of moisture content was measured.
