Evaluation of Distribution Line Spacers Located Near the Coast

Abstract: - An excellent option to the utilities has been the utilisation of covered cable fixed to the insulator or to the line spacer. However, distribution lines located near the coast are often exposed to marine pollution and then the superficial resistance of the polymeric material can be reduced and leakage current can flow on the polymeric surface. This paper shows the results of investigation considering covered cable and line spacers. By testing the polymeric material, the behaviour of the leakage current and the evolution of degradation were analysed, aiming the on-line monitoring of the leakage current of line spacers.

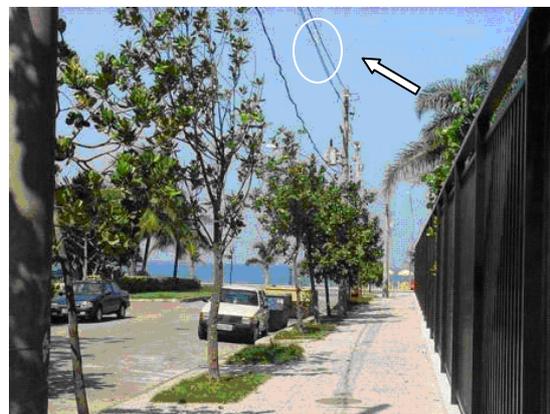
Fig.3 – Distribution line near the coast.

Two types of line spacers are commonly used, as shown in Fig.2. A distribution line situated near the coast is shown in Fig.3. The technical information and electrical characteristics of line spacers can be seen on Table I.

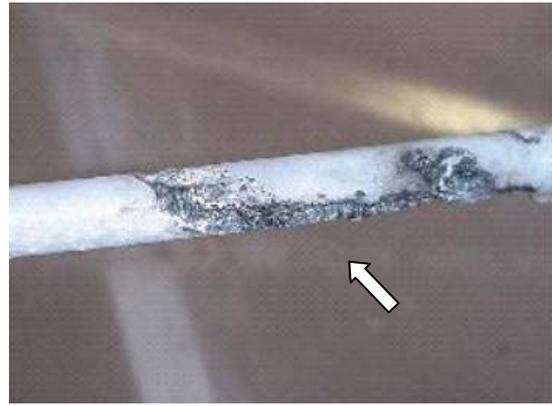
Fig.9 – Detail of the covered cable.

On the 22nd day of test (540 hours), it was observed erosion on the surface of the recovered cable, in the proximity of one of the line spacers, as shown in Fig.8 and Fig.9.

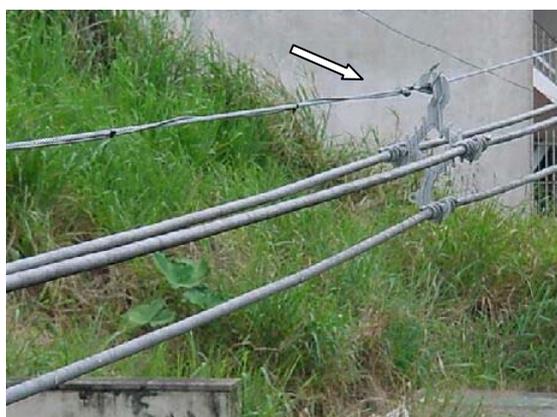
Fig.18 – Details of installation in distribution line.

Details of installation in distribution lines can be seen in Fig.17 and Fig.18, where the device and the line spacer are shown.
